**Vulnerability Assessment of Selected Buildings
Designated as Shelters
Antigua and Barbuda**

**USAID-OAS Caribbean Disaster Mitigation Project
OAS-ECHO Project to Reduce the Vulnerability of School Buildings to Natural
Disasters
1998**

**This report was prepared by
Tony Gibbs of Consulting Engineers Partnership Ltd.**

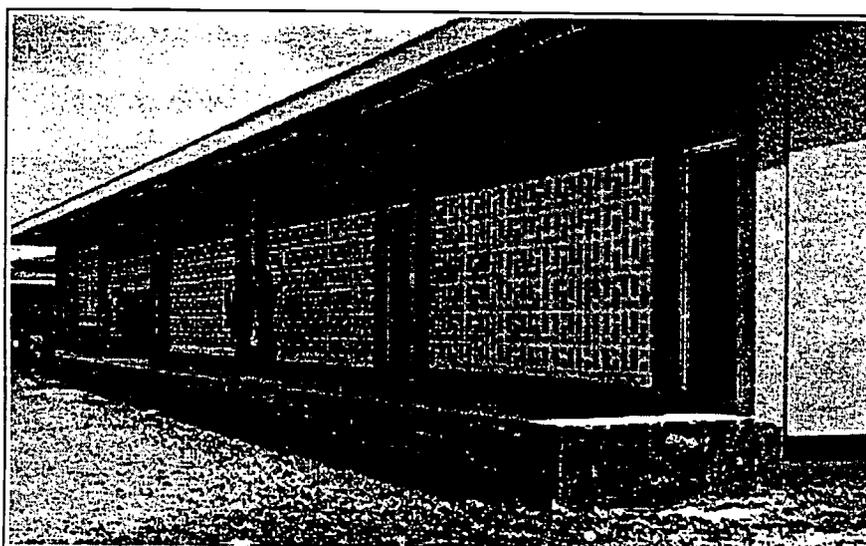
**Parham Primary
School
Parham Town,
Antigua**

Property	Individual Building and Code Number	Description of Damage	Repairs and Reconstruction
Parham Primary School	ANB-PPS-01	<ul style="list-style-type: none"> • Loss of roof over shed. • Minor damage to eaves of one block. 	<ul style="list-style-type: none"> • General maintenance and replacement of roof.
	ANB-PPS-02	<ul style="list-style-type: none"> • Roof of walkway destroyed. 	<ul style="list-style-type: none"> • General repairs.
	ANB-PPS-03	<ul style="list-style-type: none"> • Damage to roof (partial). 	<ul style="list-style-type: none"> • Replacement of damaged roof.

Property	Individual Building and Code Number	Recommendations
Parham Primary School	ANB-PPS-01	<ul style="list-style-type: none"> • Improve site drainage. • Install additional screws in vulnerable roof areas. • Improve timber roof framing connections. • Provide shutters to cover the breeze blocks.
	ANB-PPS-02	<ul style="list-style-type: none"> • Improve site drainage. • Install additional screws in vulnerable roof areas. • Improve timber roof framing connections. • Provide shutters to cover the breeze blocks.
	ANB-PPS-03	<ul style="list-style-type: none"> • Improve site drainage. • Install additional screws in vulnerable roof areas. • Provide shutters to cover the breeze blocks.
Princess Margaret School	ANB-PMS-01	<ul style="list-style-type: none"> • Improve site drainage. • Install additional screws in vulnerable roof areas. • Improve timber roof framing connections. • Provide shutters to cover the breeze blocks. • Protect glass windows. • Improve water tightness of aluminium louvers.

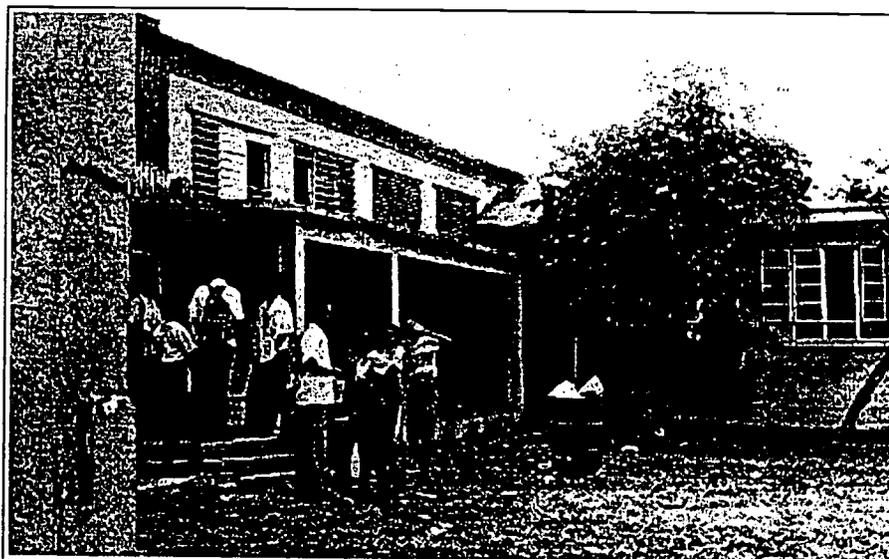
**Princess Margaret
School
St. John's, Antigua**

Princess Margaret School	ANB-PMS-01	<ul style="list-style-type: none"> • Some roof damage. 	<ul style="list-style-type: none"> • Replacement of roof.
	ANB-PMS-02	<ul style="list-style-type: none"> • Partial loss of roof and loss of windows. 	<ul style="list-style-type: none"> • Replacement of asbestos roofing with metal profile sheets.
Liberta Primary School	ANB-LPS-01	<ul style="list-style-type: none"> • N/A 	<ul style="list-style-type: none"> • Unknown
	ANB-LPS-02	<ul style="list-style-type: none"> • N/A 	<ul style="list-style-type: none"> • Unknown
Antigua Girls High School	ANB-AGH-01	<ul style="list-style-type: none"> • Partial loss of roof to main building, and damage two windows. 	<ul style="list-style-type: none"> • Roof covering was replaced after hurricane.
	ANB-AGH-02	<ul style="list-style-type: none"> • Windows were dislocated during hurricane. • Partial loss of roof. 	<ul style="list-style-type: none"> • Replacement of windows, ceiling, roofs cladding electrical fixture.

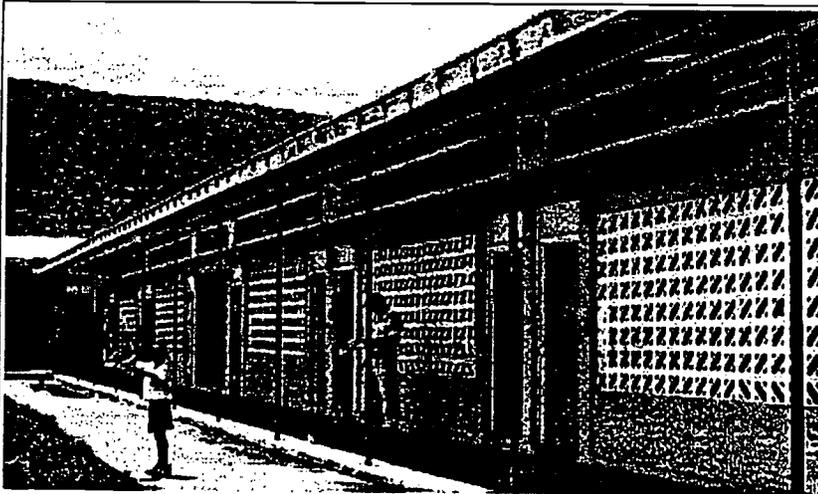
**Bolans Primary
School
Bolans Village**

Bolans Primary School	ANB-BPS-01	<ul style="list-style-type: none"> • Flooding due to rising groundwater. • Damage to doors and windows. • Loss of guttering. 	<ul style="list-style-type: none"> • Unknown
	ANB-BPS-02	<ul style="list-style-type: none"> • Flooding due to rising groundwater. • Damage to doors and windows. • Loss of guttering. 	<ul style="list-style-type: none"> • Unknown
Urlings Primary School	ANB-UPS-01	<ul style="list-style-type: none"> • Partial loss of roof to administrative block and classroom (north). 	<ul style="list-style-type: none"> • Replacement of roofing materials.
	ANB-UPS-02	<ul style="list-style-type: none"> • Loss of roof metal sheets. 	<ul style="list-style-type: none"> • Repair work to roof.
Greenbay Primary School	ANB-GRE-01	<ul style="list-style-type: none"> • Total loss of both sheeting and structure. • Parapet to upper floor of main block was torn off. • Vertical RC supports were cracked and spalling. 	<ul style="list-style-type: none"> • Repairs of damages scheduled into general maintenance. • Improvement regarding the shape and slope of roof was made.

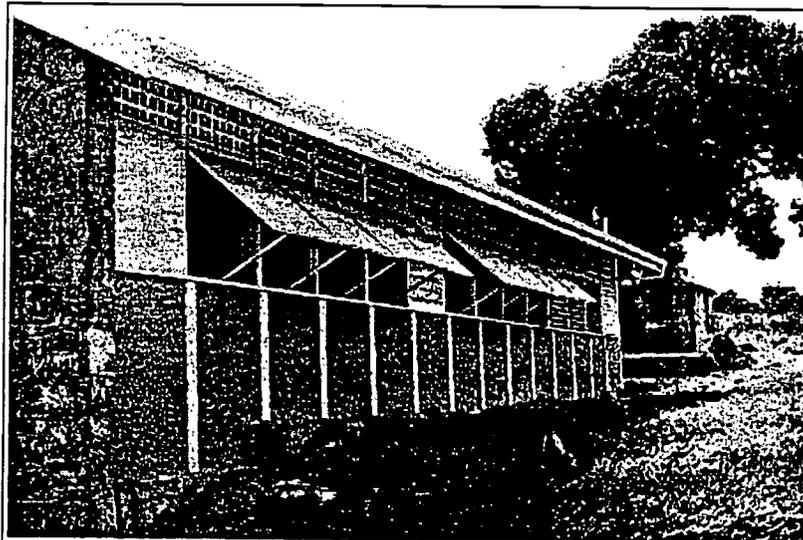
**New Winthropes
Primary School
Barnes Hill, Antigua**

ANB-GRE-02	<ul style="list-style-type: none"> • Loss of the veranda (covered walkways). 	<ul style="list-style-type: none"> • Hurricane straps were included in reconstruction.
New Winthropes Primary School	ANB-NWS-01	<ul style="list-style-type: none"> • None 	<ul style="list-style-type: none"> • General maintenance only.
	ANB-NWS-02	<ul style="list-style-type: none"> • None 	<ul style="list-style-type: none"> • None
T.N. Kirnon School	ANB-TNK-01	<ul style="list-style-type: none"> • Minimal damage except for balcony roof which was lost. 	<ul style="list-style-type: none"> • General maintenance only.
	ANB-TNK-02	<ul style="list-style-type: none"> • None 	<ul style="list-style-type: none"> • General maintenance only.

ANB-GRE-02	<ul style="list-style-type: none"> • Install additional screws in vulnerable roof areas. • Improve water tightness of aluminium louvers.
New Winthropes Primary School	ANB-NWS-01	<ul style="list-style-type: none"> • Improve site drainage. • Install additional screws in vulnerable roof areas. • Improve timber roof framing connections. • Strengthen un-reinforced stone masonry walls. • Repair cracked columns. • Provide shutters to cover the breeze blocks. • Install shutters over open windows.

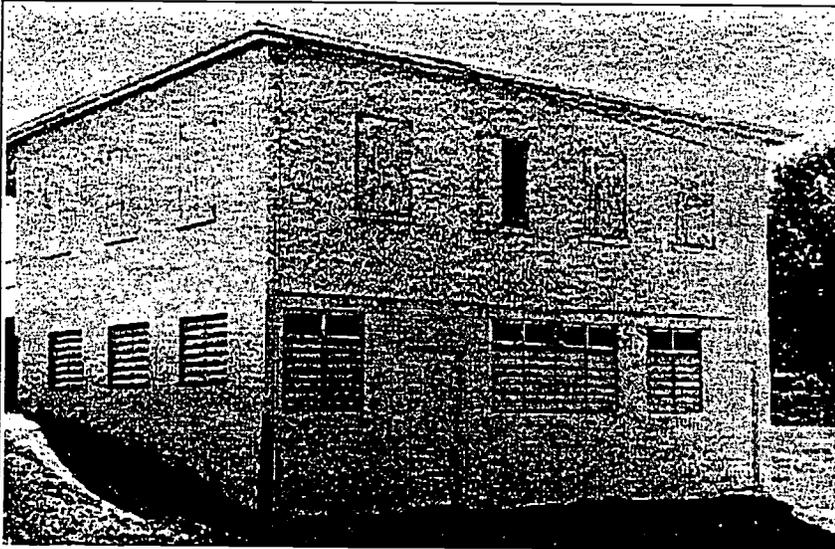
**Antigua Grammar
School
St. John's, Antigua**

Antigua Grammar School	ANB-AGS-01	<ul style="list-style-type: none"> • Loss of canopy over entrance. • Loss of metal roof sheeting (5-10%). • Flooding due to loss of roof. 	<ul style="list-style-type: none"> • Replacement of metal sheeting.
	ANB-AGS-02	<ul style="list-style-type: none"> • Loss of windows. • Damage to porch roof. • Loss of roof metal sheeting. 	<ul style="list-style-type: none"> • Reconstruction of structure.
John Hughes Primary School	ANB-JHS-01	<ul style="list-style-type: none"> • N/A 	<ul style="list-style-type: none"> • Unknown
Five Island School	ANB-FIS-01	<ul style="list-style-type: none"> • Loss of roof. 	<ul style="list-style-type: none"> • Unknown
	ANB-FIS-02	<ul style="list-style-type: none"> • Loss of roof and windows. 	<ul style="list-style-type: none"> • Replacement of roof structure and sheeting.
J.T. Ambrose School	ANB-JTA-01	<ul style="list-style-type: none"> • Loss entire roof (main hall). 	<ul style="list-style-type: none"> • Repair roof.

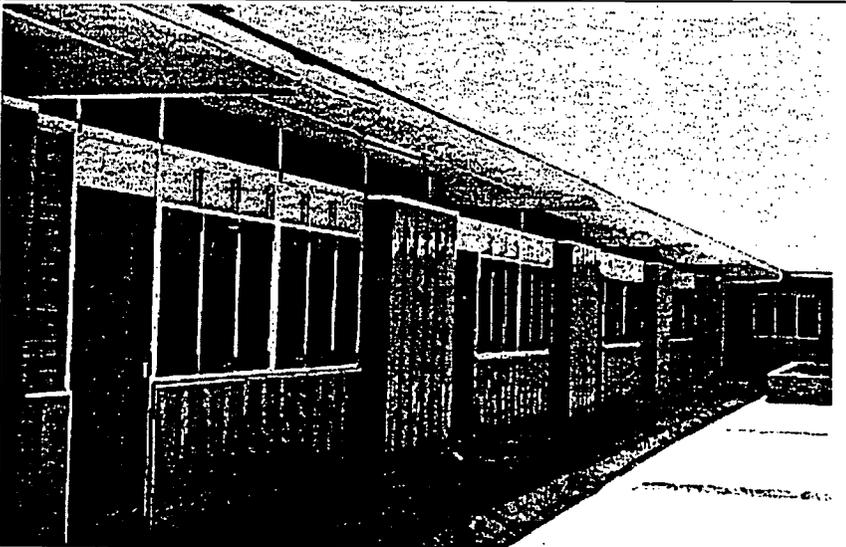
**Glanvilles Primary
School
Glanvilles Village,
Antigua**

Glanvilles Primary School	ANB-GPS-01	<ul style="list-style-type: none"> • Rotted cladding was torn away. • Upturned ceiling tore off. 	<ul style="list-style-type: none"> • Unknown
Bendals Primary School	ANB-BDS-01	<ul style="list-style-type: none"> • Loss of walkway canopy. • Partial loss of roof. 	<ul style="list-style-type: none"> • Replacement of lost sheeting.
Ottos Compre-hensive School	ANB-OCS-01	<ul style="list-style-type: none"> • Loss of some windows, doors and shutters. 	<ul style="list-style-type: none"> • Replacement of all doors. • Repair to windows and shutters.
	ANB-OCS-02	<ul style="list-style-type: none"> • Loss of some windows, doors and shutters. 	<ul style="list-style-type: none"> • Replacement of windows and all doors.

Glanvilles Primary School	ANB-GPS-01	• Install additional screws in vulnerable roof areas.
Bendals Primary School	ANB-BDS-01	• Install additional screws in vulnerable roof areas.
Ottos Comprehensive School	ANB-OCS-01	• Repair and protect glass windows.
	ANB-OCS-02	• Provide shutters to cover the breeze blocks.
