**TITLE** Solar Heating Experiment on the Grover Cleveland School, Boston, Massachusetts. Final Report.  
**INSTITUTION** General Electric Co., Philadelphia, Pa. Space Div.  
**SPONS AGENCY** National Science Foundation, Washington, D.C. RANN Program.  
**REPORT NO** NSF-RA-N-74-064  
**PUB DATE** 15 Jul 74  
**NOTE** 207p.; Related documents are EA 006 622-625; Photographs will reproduce poorly

NSF-RA-N-74-064  
CONTRACT NO. NSF-C-869  
15 JULY 1974

**Final Report  
of the  
SOLAR HEATING EXPERIMENT  
on the  
GROVER CLEVELAND SCHOOL  
BOSTON, MASSACHUSETTS**

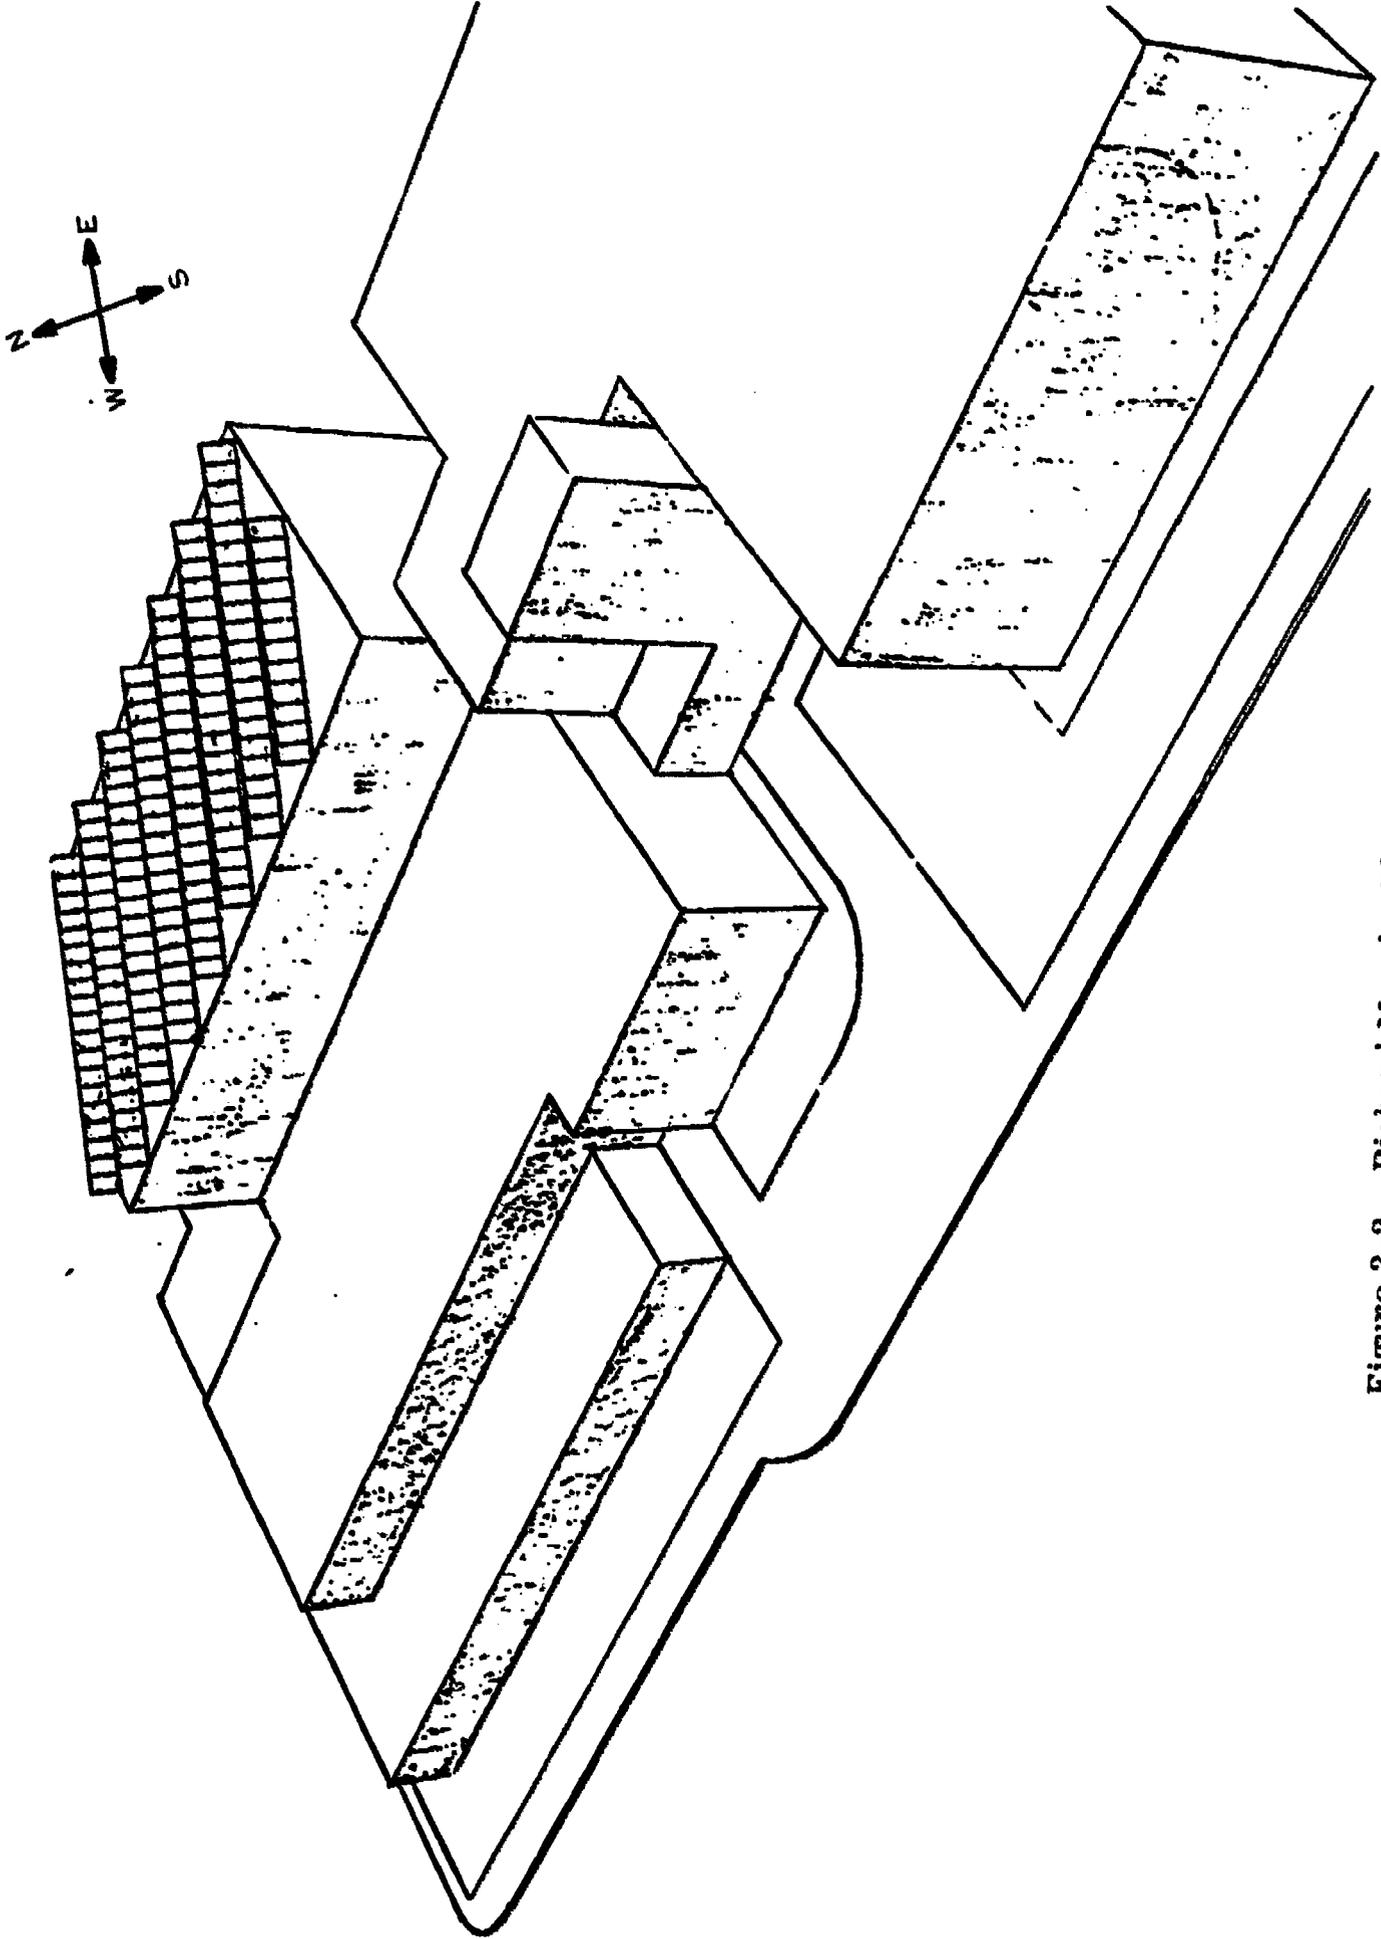
Figure 3-2. Richard Murphy Elementary School

TOTAL COLLECTOR AREA = 4800 SQ. FT.  
7 + ROWS - 1 HIGH, 20 WIDE  
4 FT. X 8 FT. COLLECTORS

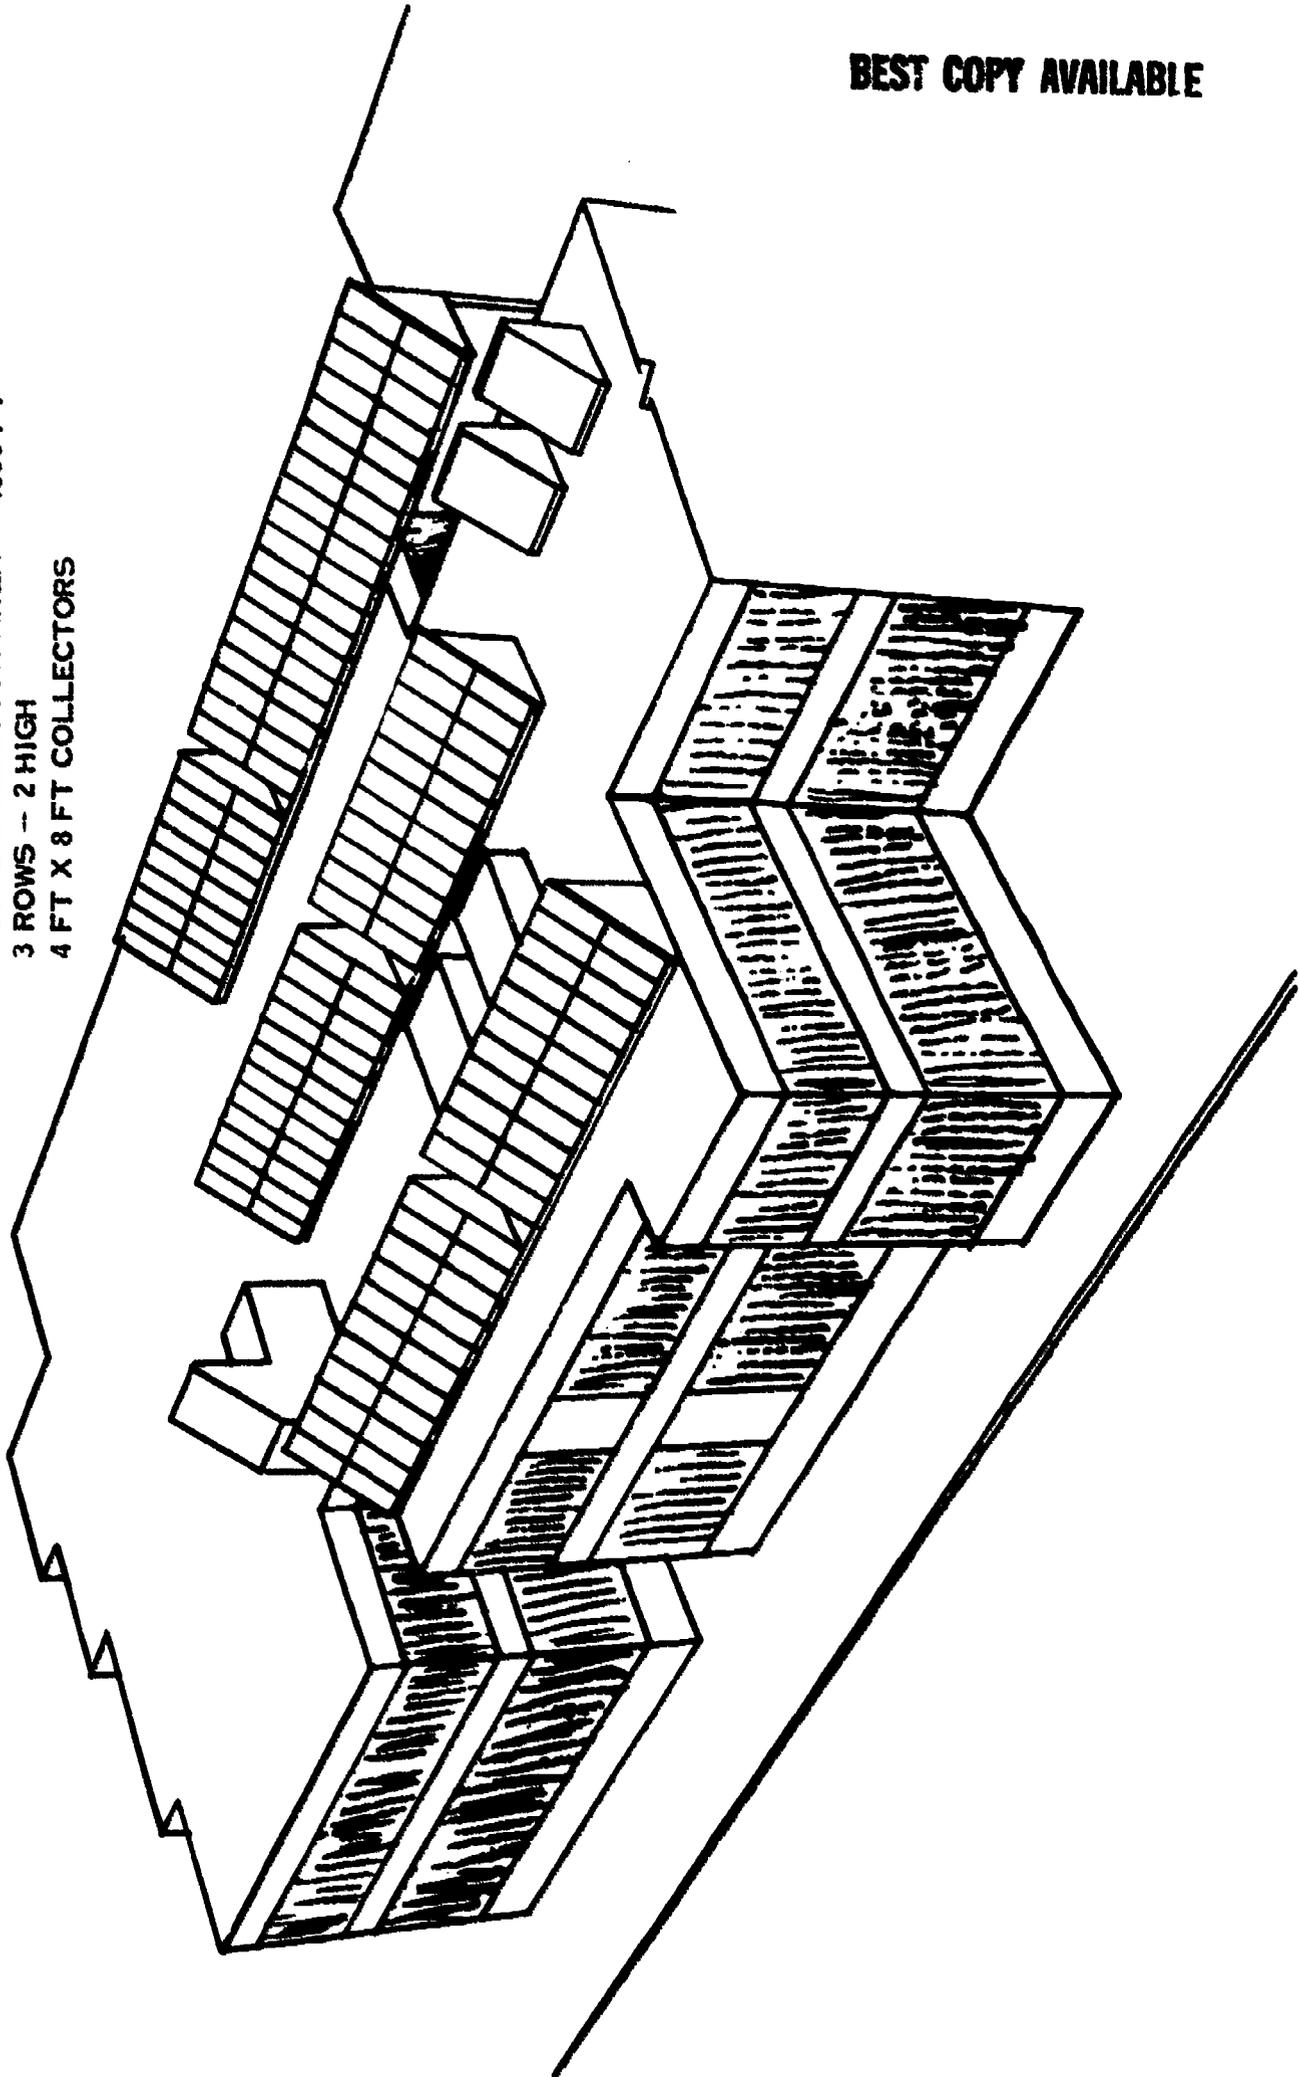
Figure 3-3. Grover Cleveland School

TOTAL COLLECTOR AREA = 4600 FT<sup>2</sup>  
3 ROWS - 2 HIGH  
4 FT X 8 FT COLLECTORS

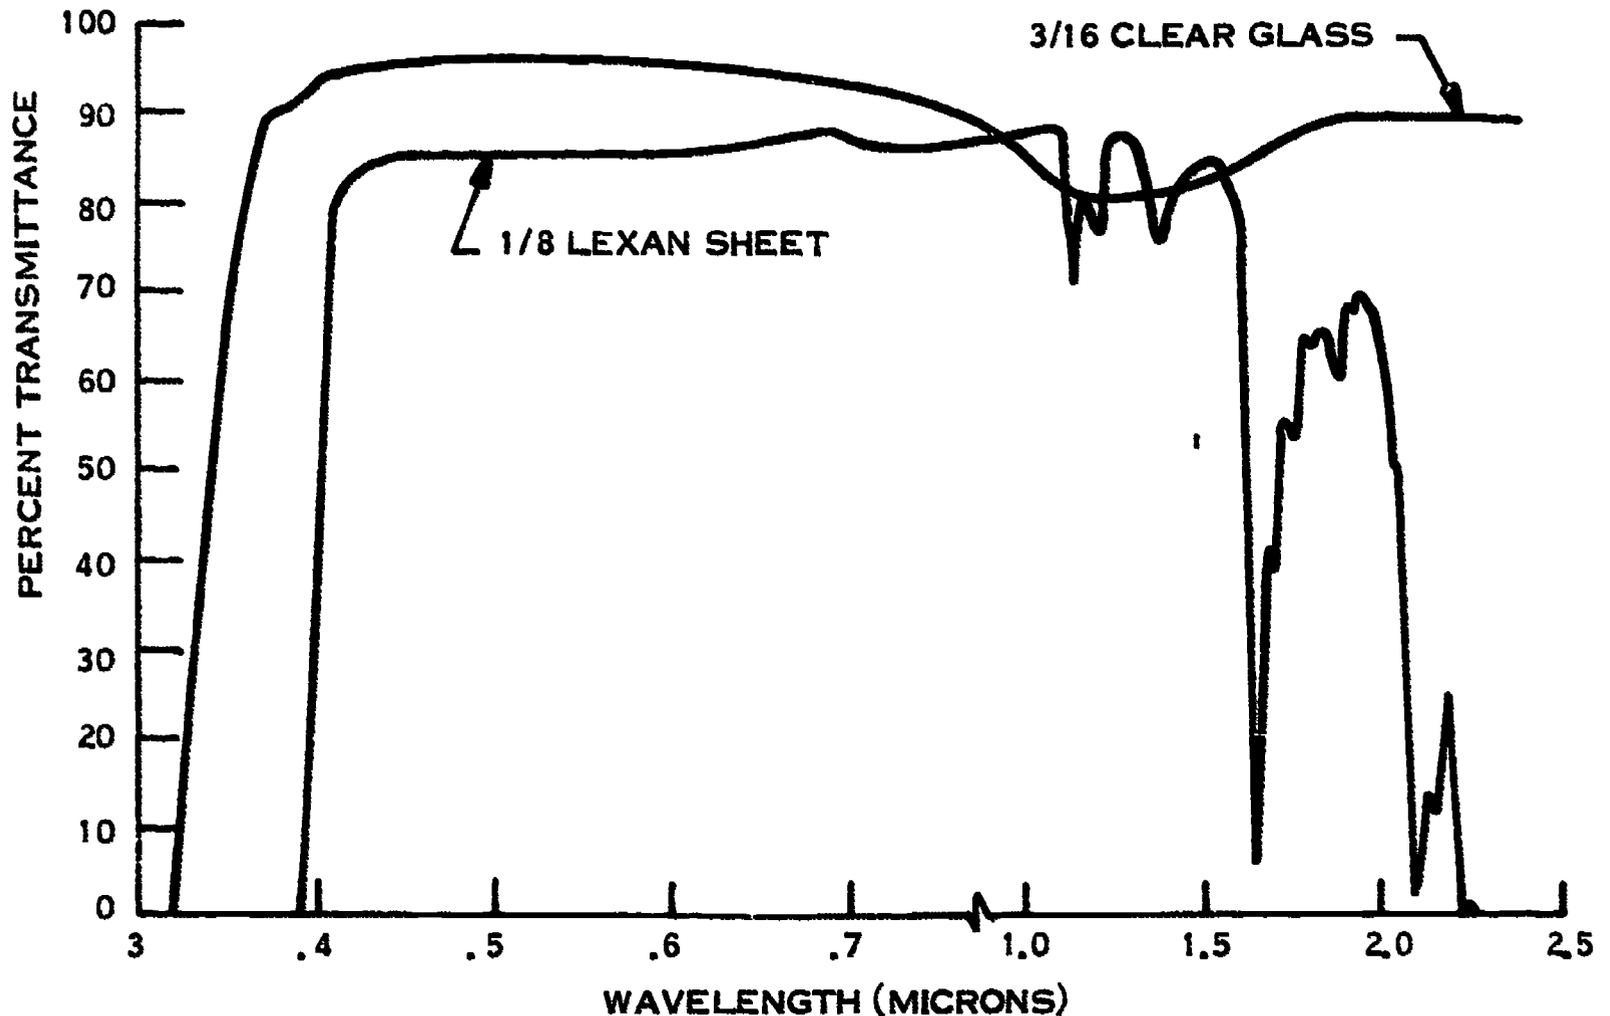
Figure 4-6. Spectral Transmittance of Window Materials

While normal 0.09 inch window glass is relatively low in cost (on the order of \$0.20 per square foot in large quantities) tempering, greater thicknesses, and low iron formulations all add significantly to the cost. Recent quotes to GE from major glass manufacturers for large quantities of tempered normal and low iron glass range from \$0.46 per square foot for normal 1/8 inch (DS) tempered to \$1.96 per square foot for 7/32 inch tempered low iron glass. One eighth inch thick tempered glass is of questionable suitability for the outer surface of collectors larger than 3 by 6 ft because of wind loading considerations. Some manufacturers are hesitant to quote large sizes of 1/8 or 5/32 tempered glass because of handling difficulties.

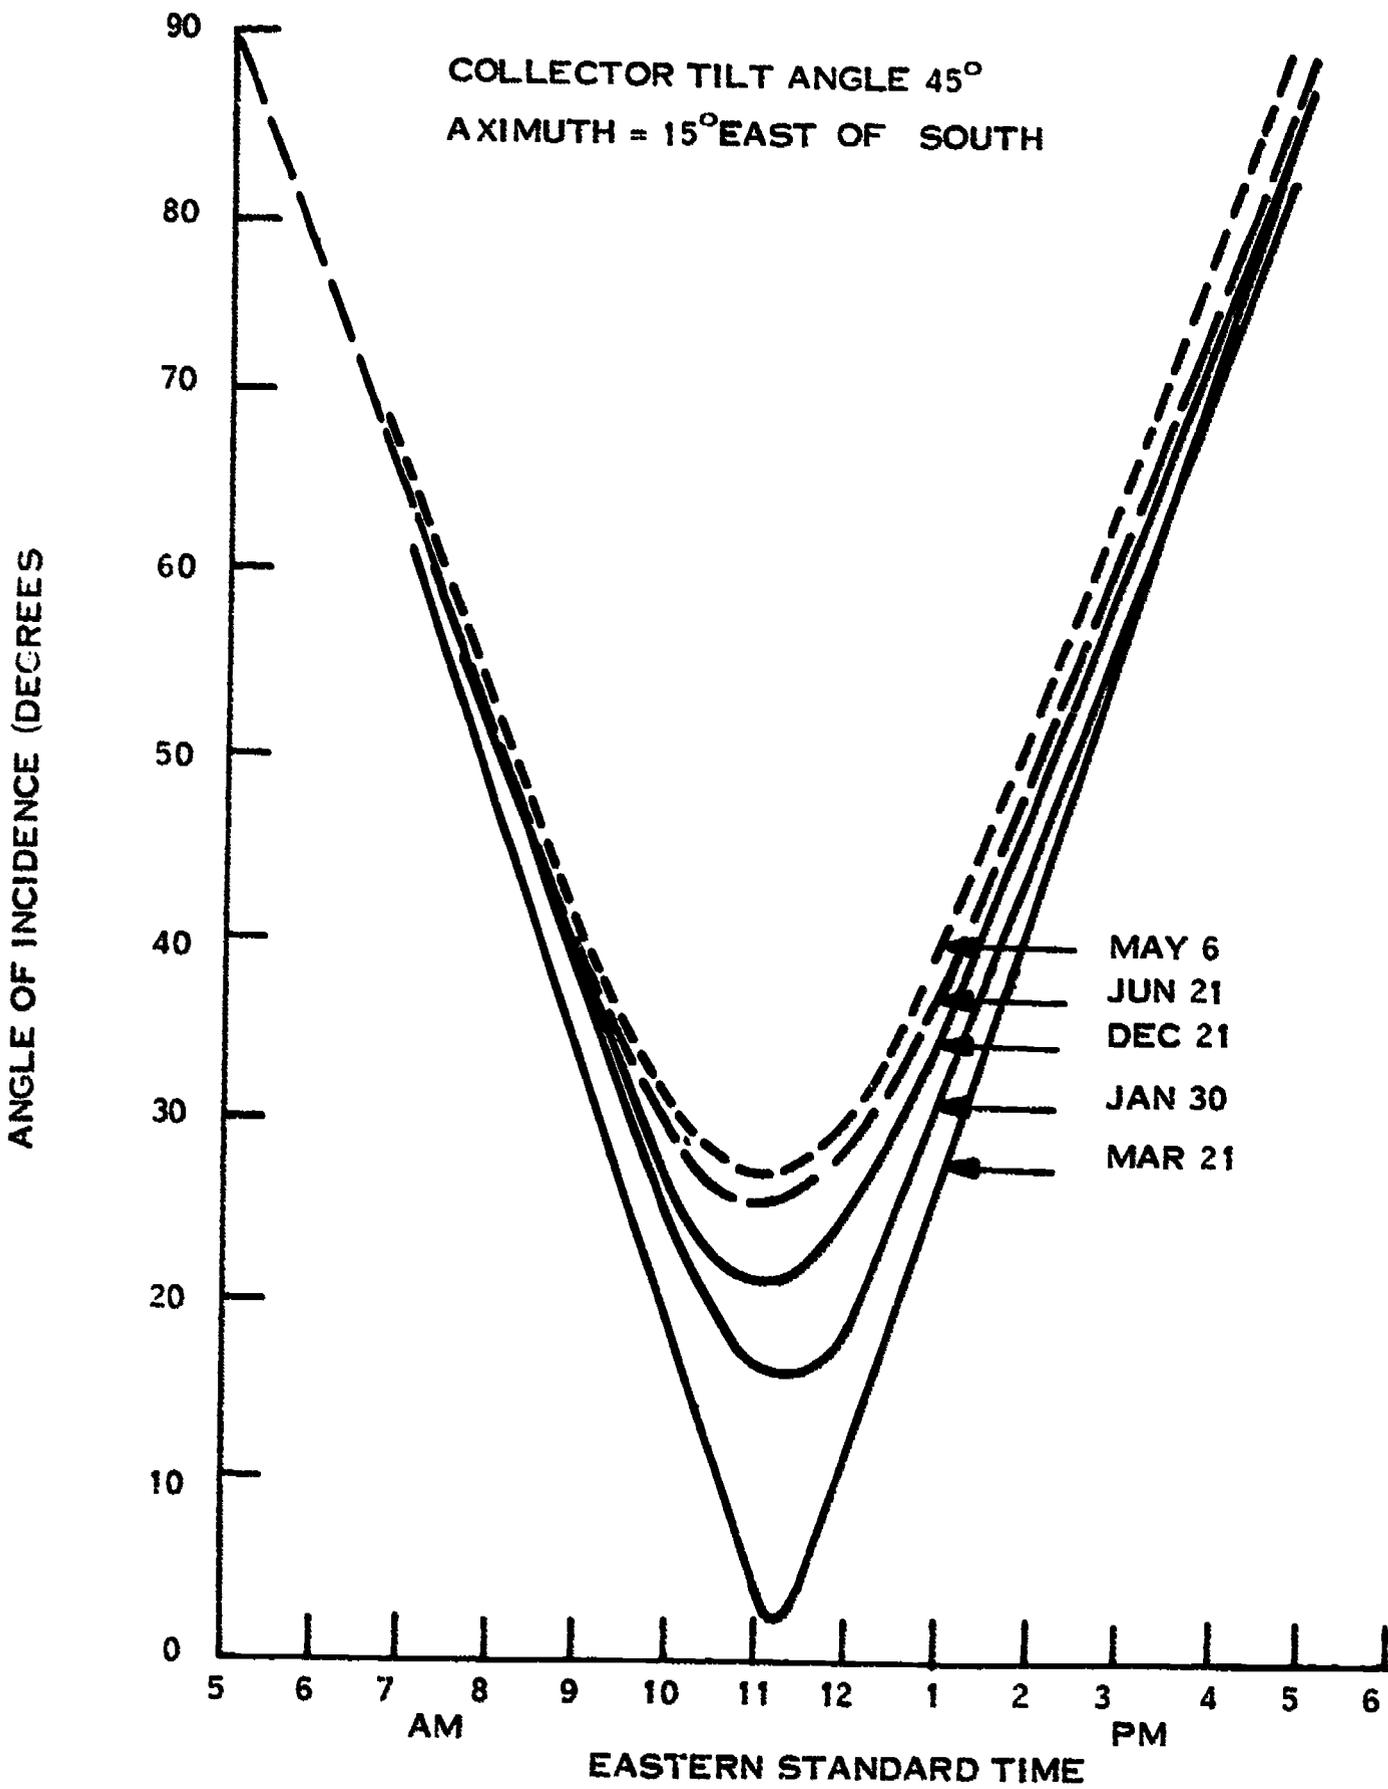
Figure 4-11. Direct Sunlight Incidence Angle Variation for the Grover Cleveland School Solar Collectors

1. Year round performance testing (see Figure 4-11 for sun angle effects)
2. Heating (steeper angles are better but sky conditions in late December/early January nullify the benefits of much steeper angles)
3. Ease of construction layout by the steel fabricator
4. Visual match with skylights

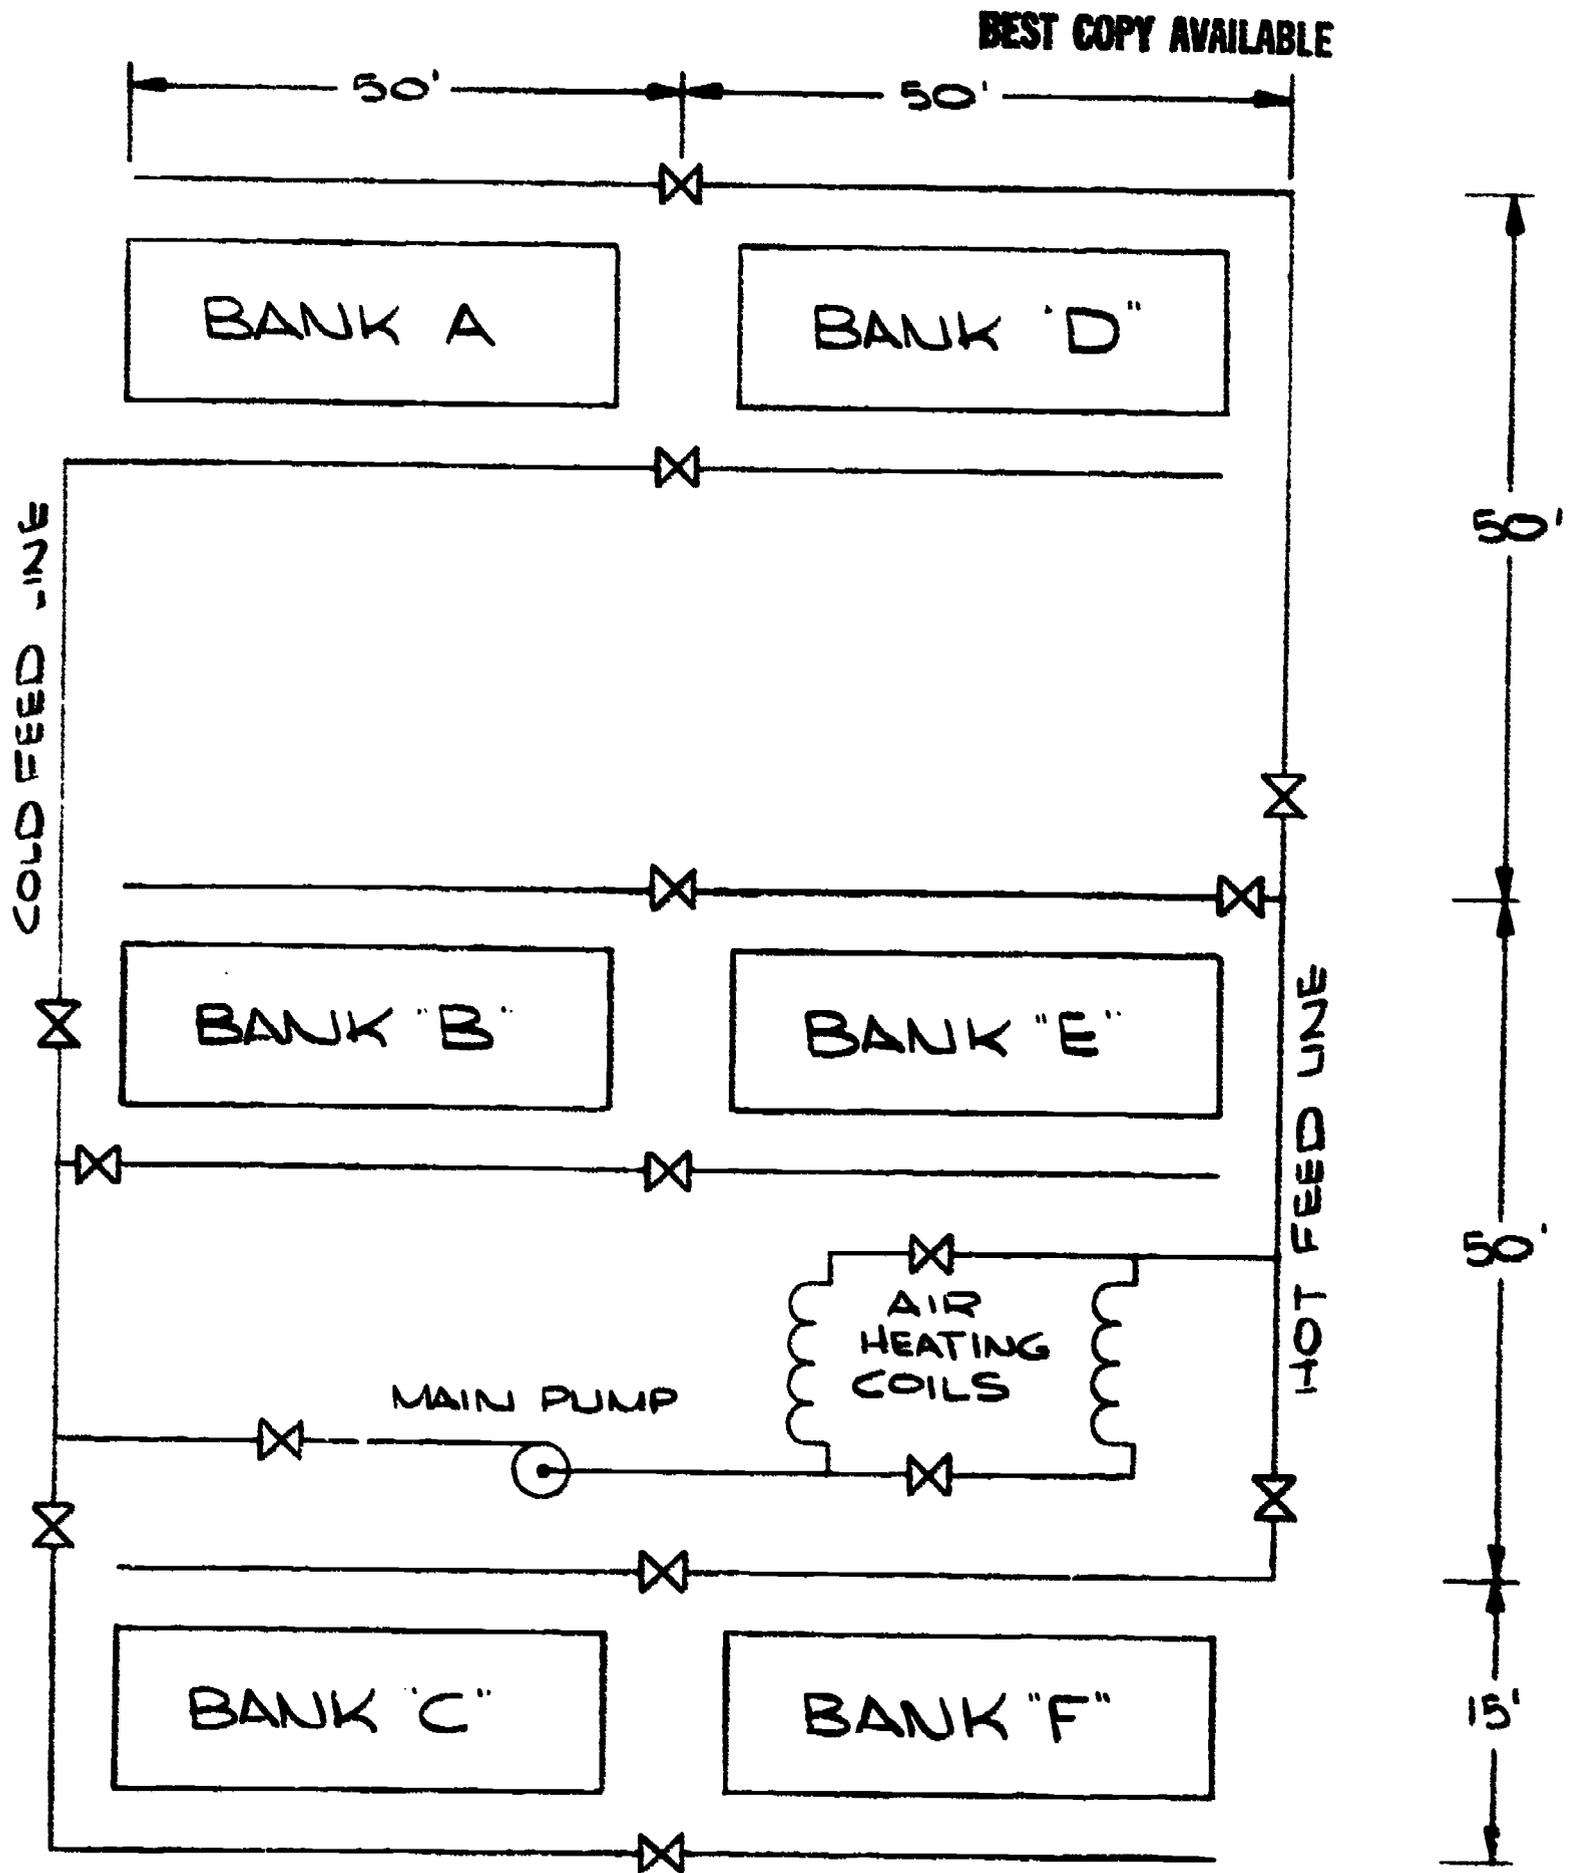
Figure 4-13. Side Feed Piping Network

The transient system response is addressed by the first and last consideration and the system efficiency by the second and last consideration. The cost of fittings, valves and hydraulic instrumentation is addressed by the last consideration.

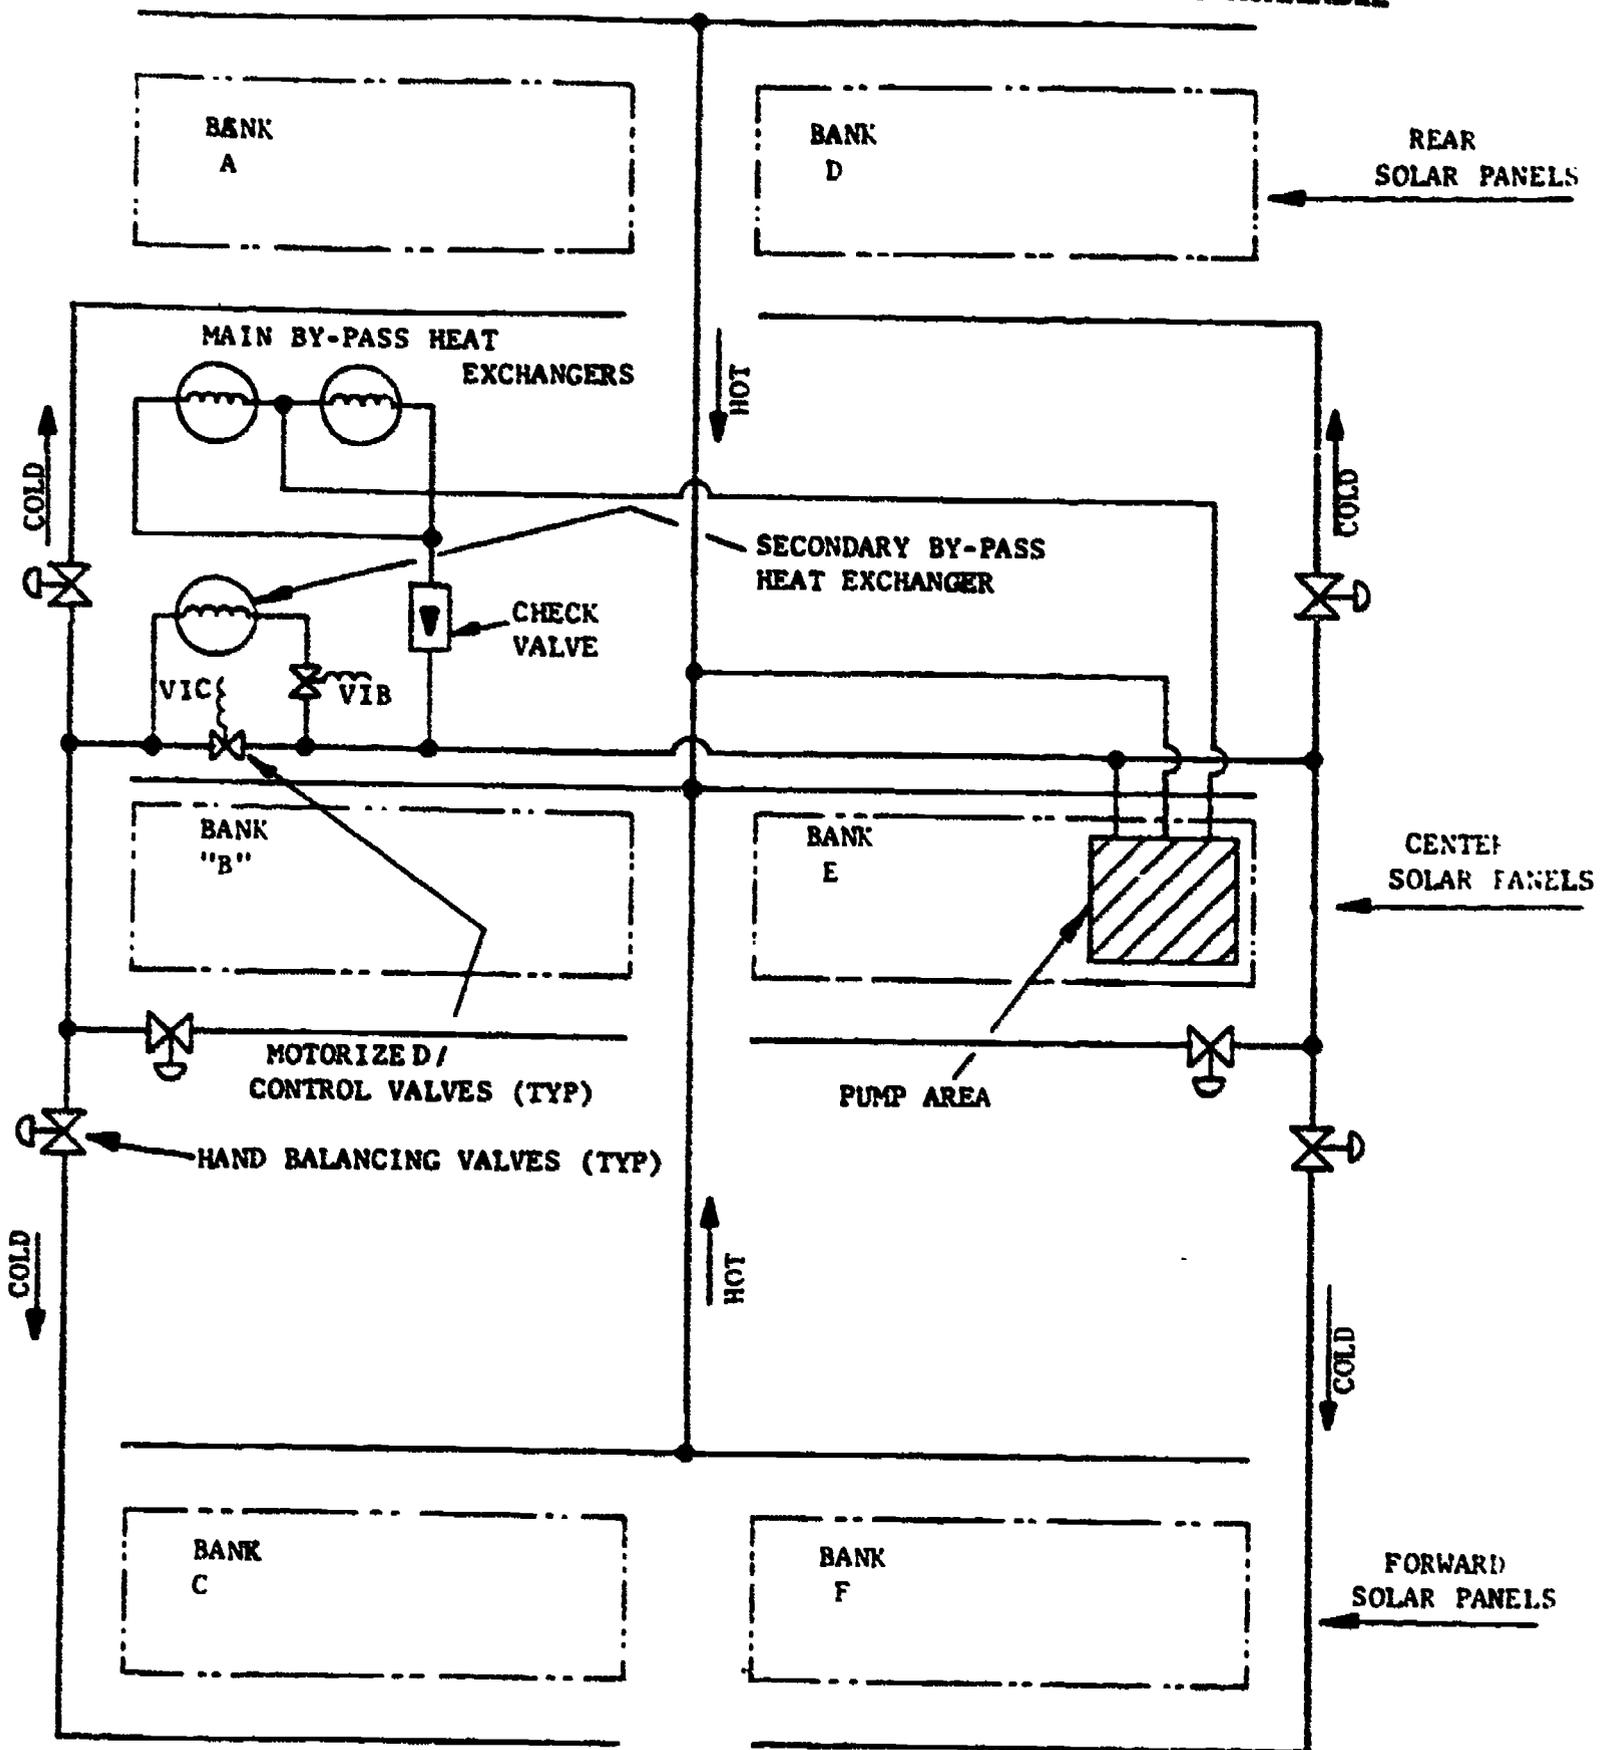
Figure 4-15. Piping Schematic - Minimum Feed Volume, Minimum Header Volume and Minimum Hot Pipe Surface

As this work was being completed the control concepts were being finalized and a location was found near the east end of Bank E capable of supporting a small thermal energy storage tank. A location underneath Bank E was selected for the main pump area and a new feature was added to the system. The new feature is the three bypass heat exchangers discussed in Subsection 4.2.3.2 following. They are basically liquid to air auxiliary heat exchangers which provide the capability to dump excess heat which cannot be utilized (a typical summer situation) and to accelerate the morning warmup transient. At this point reflection on overall system reliability also led to the conclusion that pressure should be minimized on the collector's rubber hose connections and, consequently, the main pump was relocated to place the suction side immediately downstream of the collector outlet. Main pump NPSH requirements were satisfied by pressurizing a make up water tank. The unconventional placement of the pump on the "Hot" side of the loop is not as significant as it would appear, since the loop temperature differential decreases substantially as the temperature level increases (due to both collector efficiency and system mode changes).

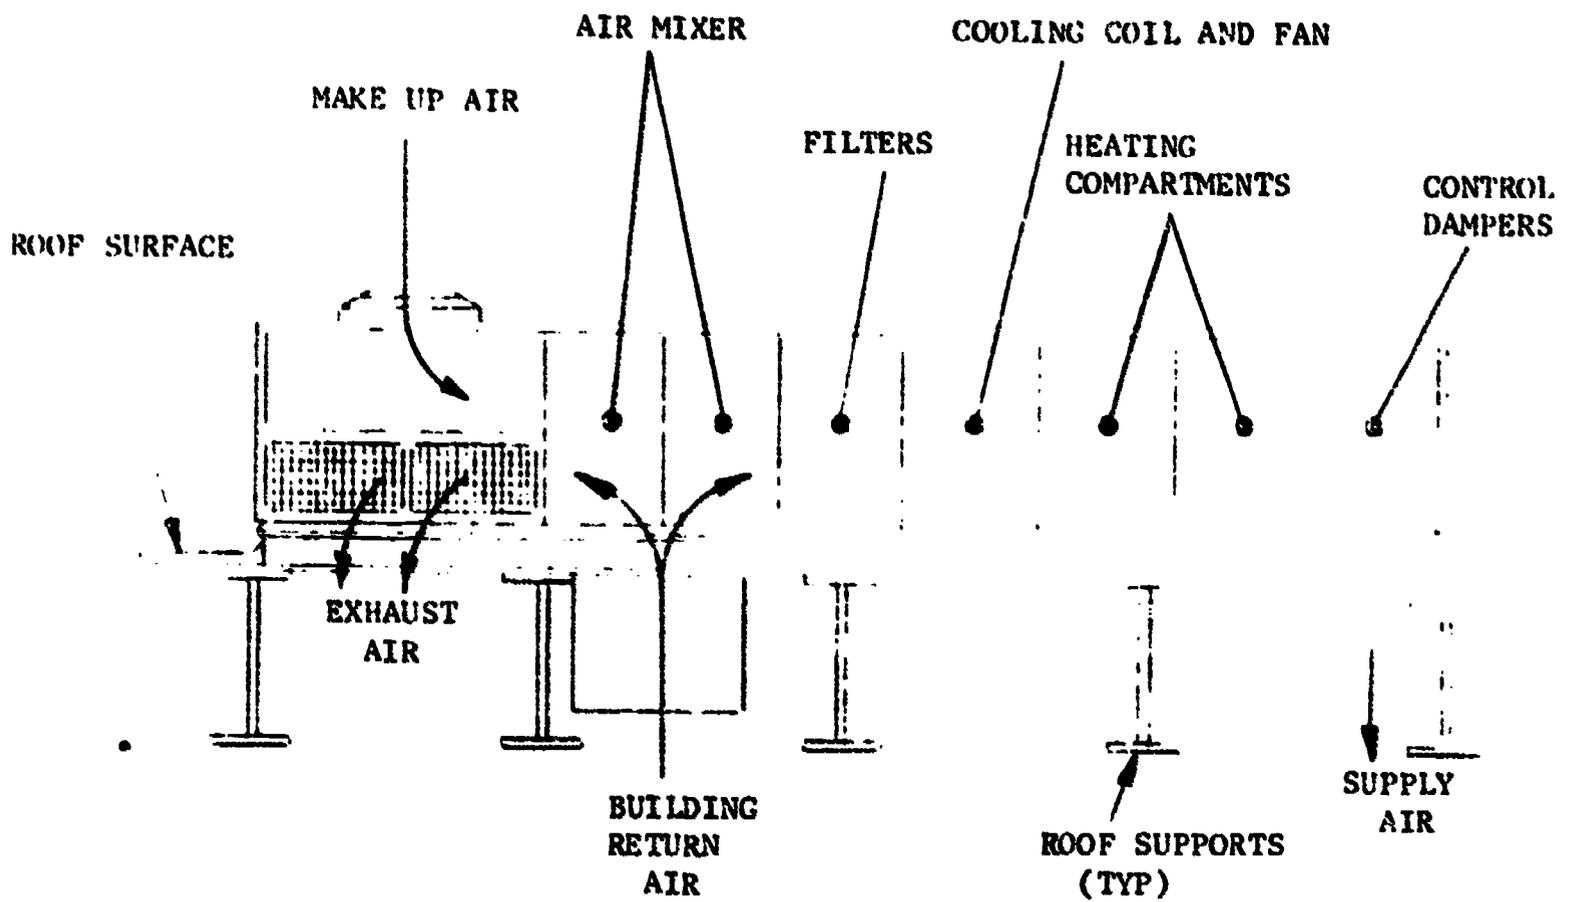
Figure 4-17. Side Elevation of Nesbitt Roof Heating/Cooling Unit

An exterior view of one of the units was shown in Figure 4-9 and Figure 4-17 provides a side view with the locations of various functions identified. It is possible with care and qualifications to place heating coils in any or all of the locations shown in Figure 4-18; however, many of the locations are not desirable. The function of the unit is to draw return air from the school (via a fan), discharge a fraction of it and replace it with outside air. The mixed air then travels through a filter section, the air conditioning refrigeration coil, and the main blower. Downstream of the main blower, the air enters a plenum and is split horizontally into two decks; the heating elements being located in the lower or "hot deck" and the upper "cold deck" being essentially a bypass duct. Both decks terminate in two small plenum volumes immediately upstream of the dampers in the exit plane of the unit. The unit internal controls maintain hot and cold deck exit air temperatures while the room thermostats control the exit damper positions - mixing a proportion of hot and cold air to satisfy the rooms' demands. The exit planes of each of these heating units can be segregated into different individually controlled heating zones and in this case AC-6 has 10 and AC-7, 6 zones.

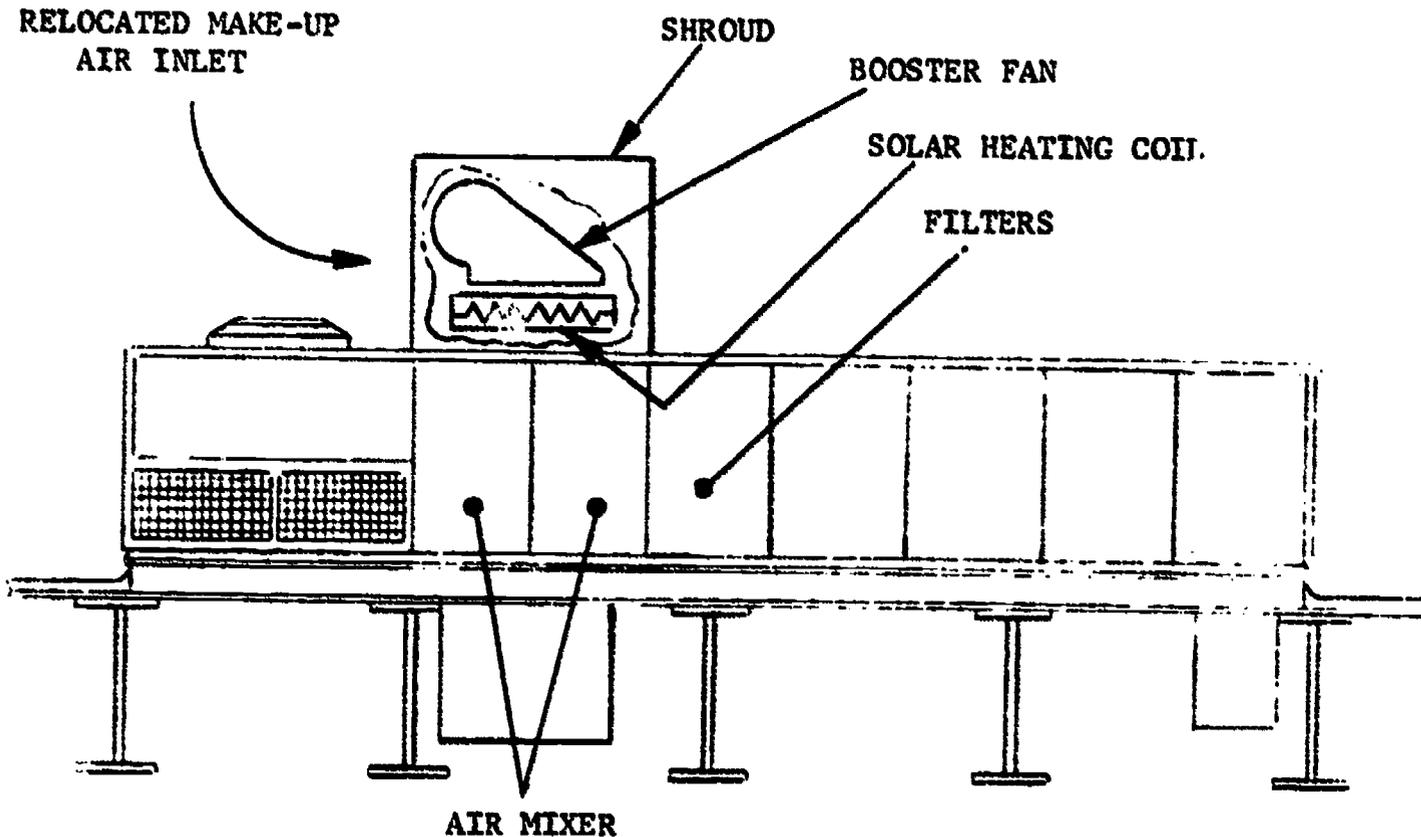
SIDE ELEVATION OF NESBITT ROOF HEATING/COOLING UNIT

1. HEATS ONLY AIR TAKEN FROM OUTSIDE
2. WOULD ELIMINATE EFFECTIVENESS OF "ECONOMIZER CYCLE" AIR CONDITIONING
3. COMPLICATED CONTROL SYSTEM
4. REQUIRES FABRICATION OF WEATHERPROOF SHROUD FOR FAN AND SOLAR HEATING COIL

Each of these locations shown in Figure 4-18 were looked at as Concepts 1 through 5 shown in Figures 4-19 through 4-23, respectively. A major functional problem was common to Concepts 1, 2 and 4 in that the effect of adding heat upstream of the hot/cold deck separation would be to heat the mixed air and, thus, the cold deck temperature. While this would be fine for the heating only situation it would either compromise unit performance during those periods when some air conditioning was needed or it would necessitate the solar heating coil cycle to a condition of no heat input whenever either economizer or refrigeration cycle air conditioning was called for. This reason along with other disadvantages led to the elimination of concepts 1, 2 and 4. Concept 3 was the simplest modification concept of all and

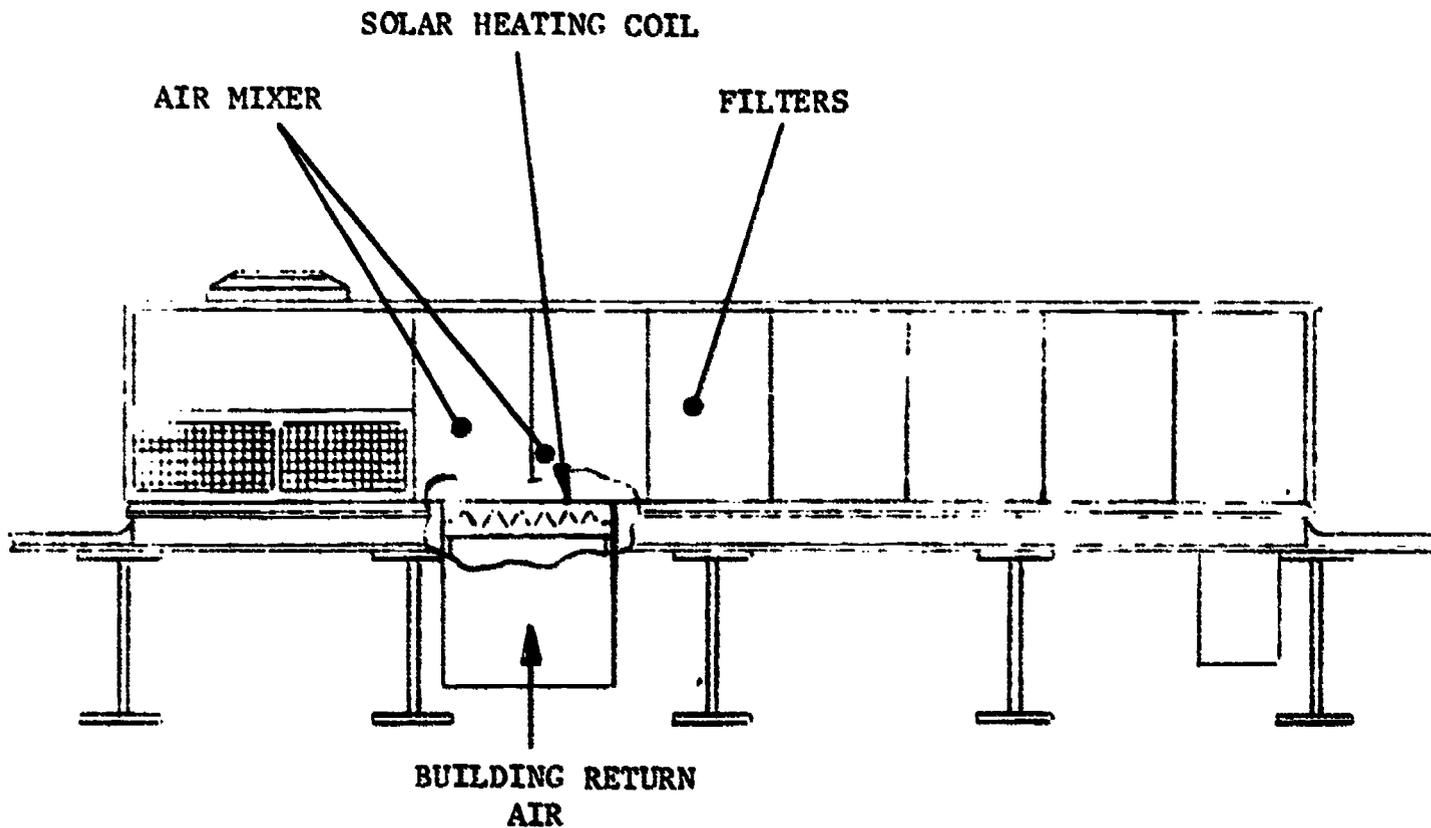
SIDE ELEVATION OF NESBITT ROOF HEATING/COOLING UNIT

1. REQUIRES ACCESS TO BOTTOM OF UNIT AT ROOF LINE
2. SOME OF HEATED AIR WOULD BE DISCHARGED VIA EXHAUST DAMPERS
3. "ECONOMIZER CYCLE" AIR CONDITIONING JEOPARDIZED BY HIGH MIXED AIR TEMPERATURES
4. COMPLICATED CONTROL SYSTEM

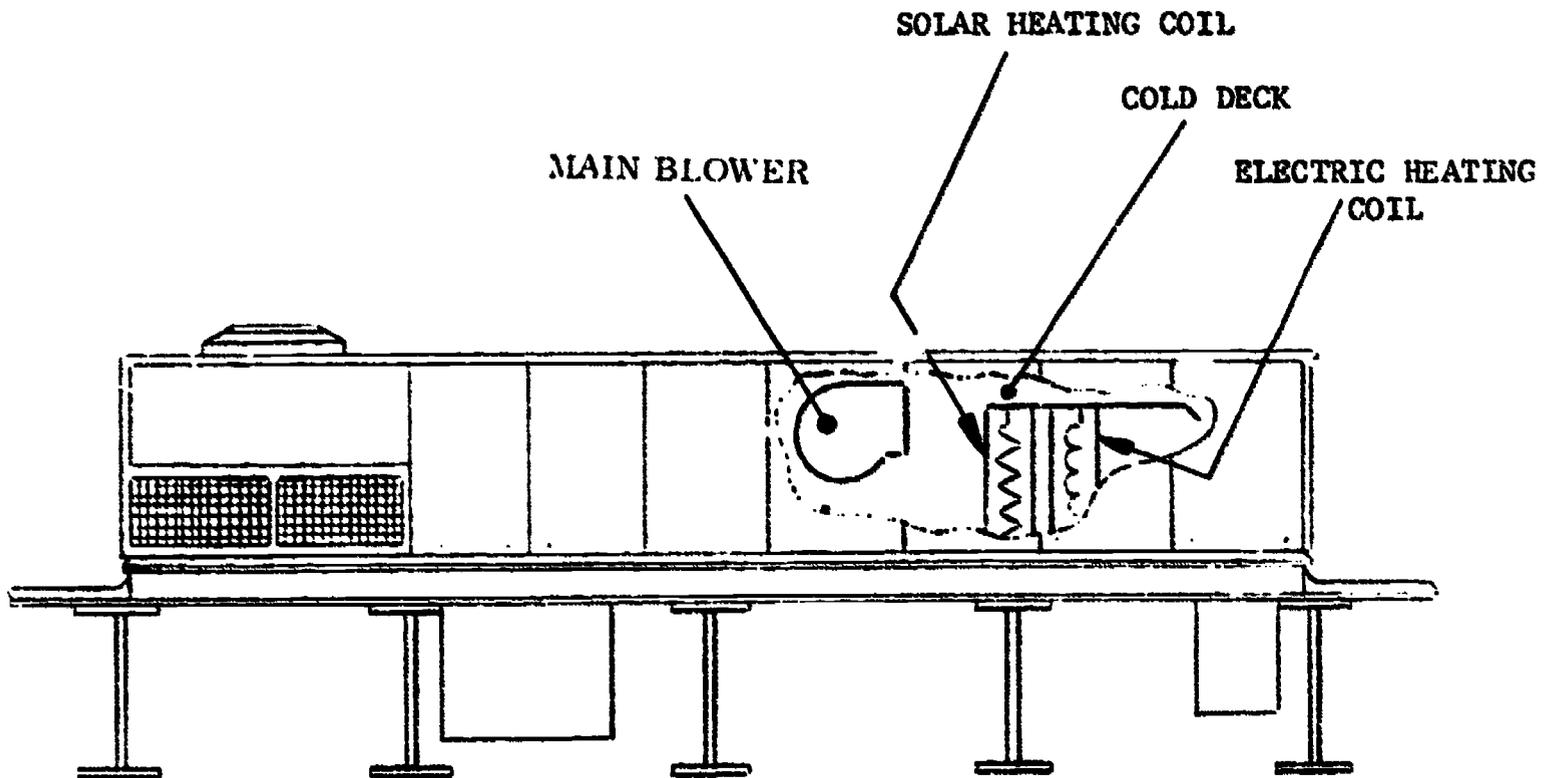
**SIDE ELEVATION OF NESBITT ROOF HEATING/COOLING UNIT**

Concept 5 was then selected and, based on discussions with Nesbitt field and factory personnel, a location in the unit's hot deck between the existing "reheat" and electric heating coils was selected. The "reheat" coil is plumbed into the air conditioning cycle's refrigerant loop and utilizes warm condensate to heat air whenever the refrigeration cycle is activated. This plumbing consideration, together with the need to provide an air plenum volume at the inlet to the hot/cold decks, required that the "reheat" coil not be relocated. The electric heating coil is smaller than the volume allocated to the "heating section" of the hot deck and also eccentric with respect to its mounting interfaces. As a result, it was deemed that the electric coil could be inverted, thus moving the coil itself downstream and providing a 7 in. X 28 in. X 70 in. internal volume available for the "solar" coil. This location had several advantages from a system standpoint, specifically:

1. The existing controls without modification would operate the Nesbitt unit since the unit controls on hot deck exit air temperature.
2. The control system for the solar system was simplified. The solar coil functions as an air pre-heater for the electric coil and thus can run at full flow normally and be shut off only when the RMA hot deck exit temperature becomes excessive or the unit goes on refrigeration cycle air conditioning.
3. It was a relatively straightforward physical modification with relocation of some mercury wetted relays being the only additional complication.
