**TITLE** Solar Heating Experiment on the Grover Cleveland School, Boston, Massachusetts. Final Report.  
**INSTITUTION** General Electric Co., Philadelphia, Pa. Space Div.  
**SPONS AGENCY** National Science Foundation, Washington, D.C. RANN Program.  
**REPORT NO** NSF-RA-N-74-064  
**PUB DATE** 15 Jul 74  
**NOTE** 207p.; Related documents are EA 006 622-625; Photographs will reproduce poorly

NSF-RA-N-74-064  
CONTRACT NO. NSF-C-869  
15 JULY 1974

**Final Report  
of the  
SOLAR HEATING EXPERIMENT  
on the  
GROVER CLEVELAND SCHOOL  
BOSTON, MASSACHUSETTS**

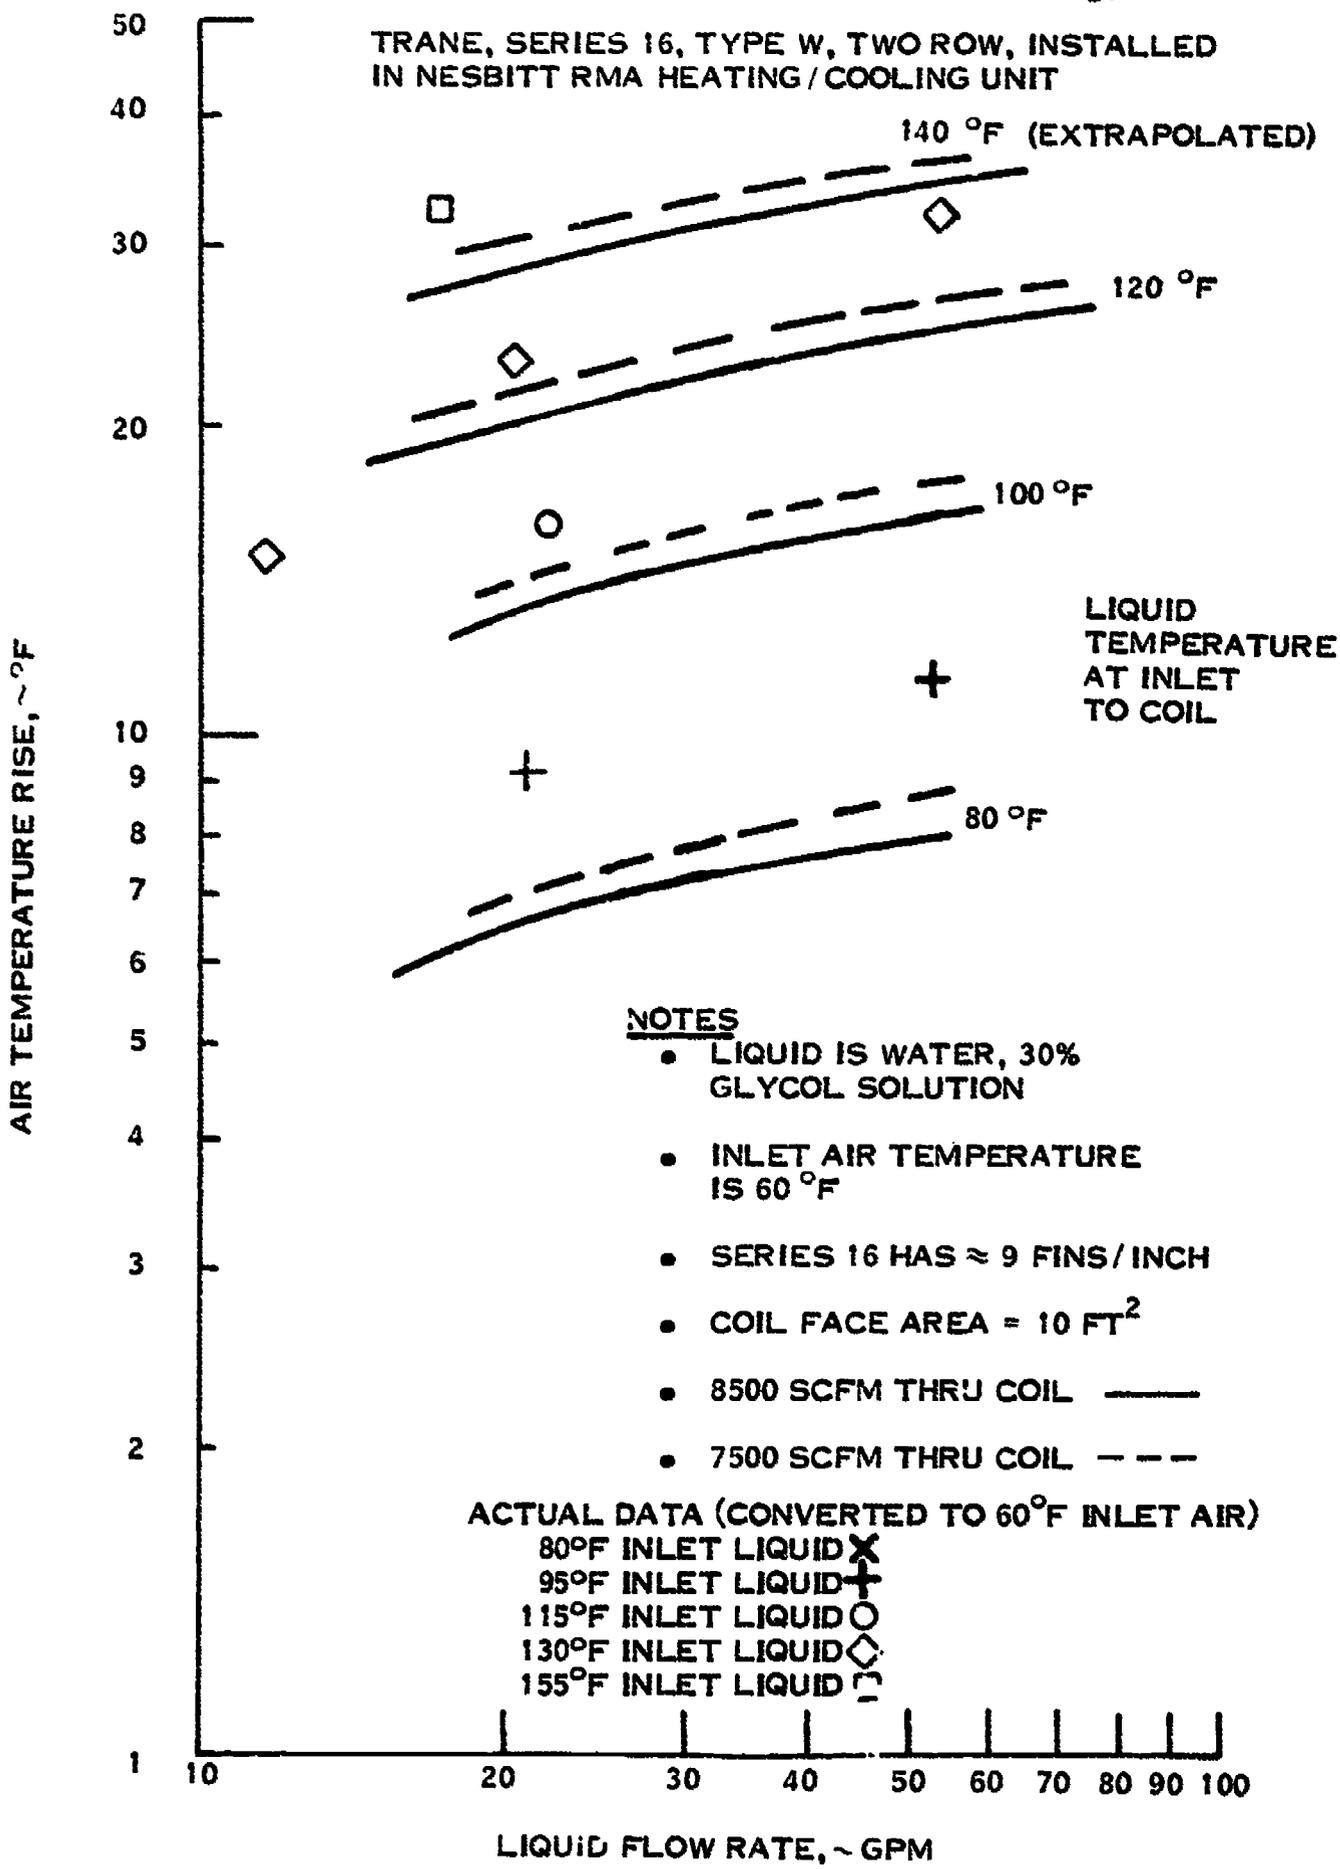
Figure 4-24. Predicted Heating Performance for Water/Glycol Coil

air entering the hot deck will be building return air and the fan work will have raised the air temperature some. If it is ascertained that the entering air (which is also cold deck air) differs markedly from 60° F, the curve is still valid with the modification that liquid temperature should be replaced by entering liquid to air temperature difference; thus the four curves are for  $\Delta T$ 's of 50, 60, 40 and 20° F moving from top down on the figure. The 140° F pair of curves is an extrapolated set. The sensitivity to air flow within the operating ranges is shown as the approximately 7 percent change in air temperature rise for a 1000 SCFM variation in air flow rate. It is expected that in "normal" operation an air temperature rise of 20 to 30° F across the solar coil will be achieved. In the majority of the March-May time frame this should be all that the building will require since normally the hot deck control point varies from 70 to 130° F and the 90 to 130° F portion of the range is only experienced under high heating demand situations. Some actually experienced operating points are also shown on Figure 4-24 for comparison. The generally "high" values of air temperature rise are due to the likelihood of less than 7500 SCFM air flow through the hot deck.

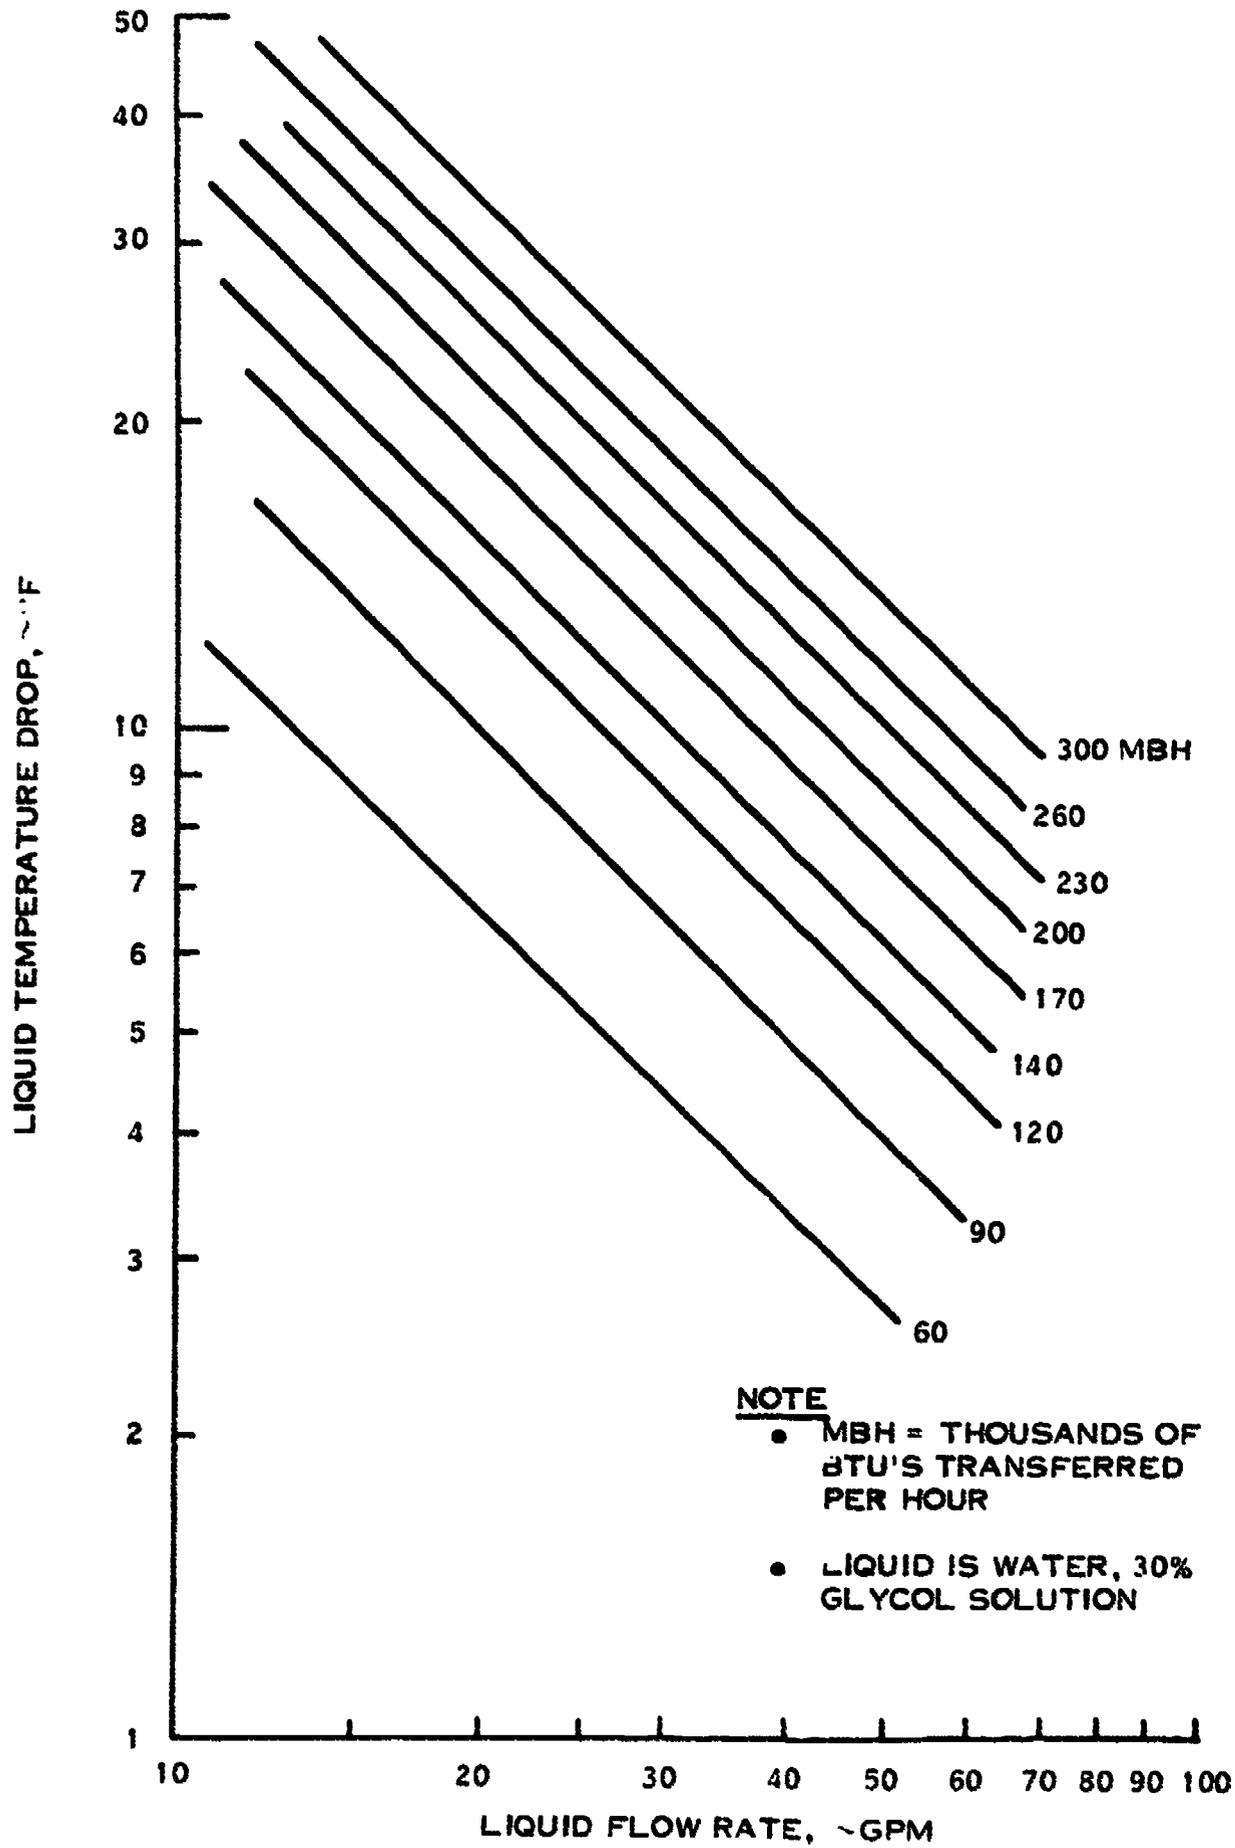
Figure 4-25. Predicted Heat Transfer Characteristics Based on Water Side Data for Water/Glycol Coil

TRANE, SERIES 16, TYPE W, TWO ROW

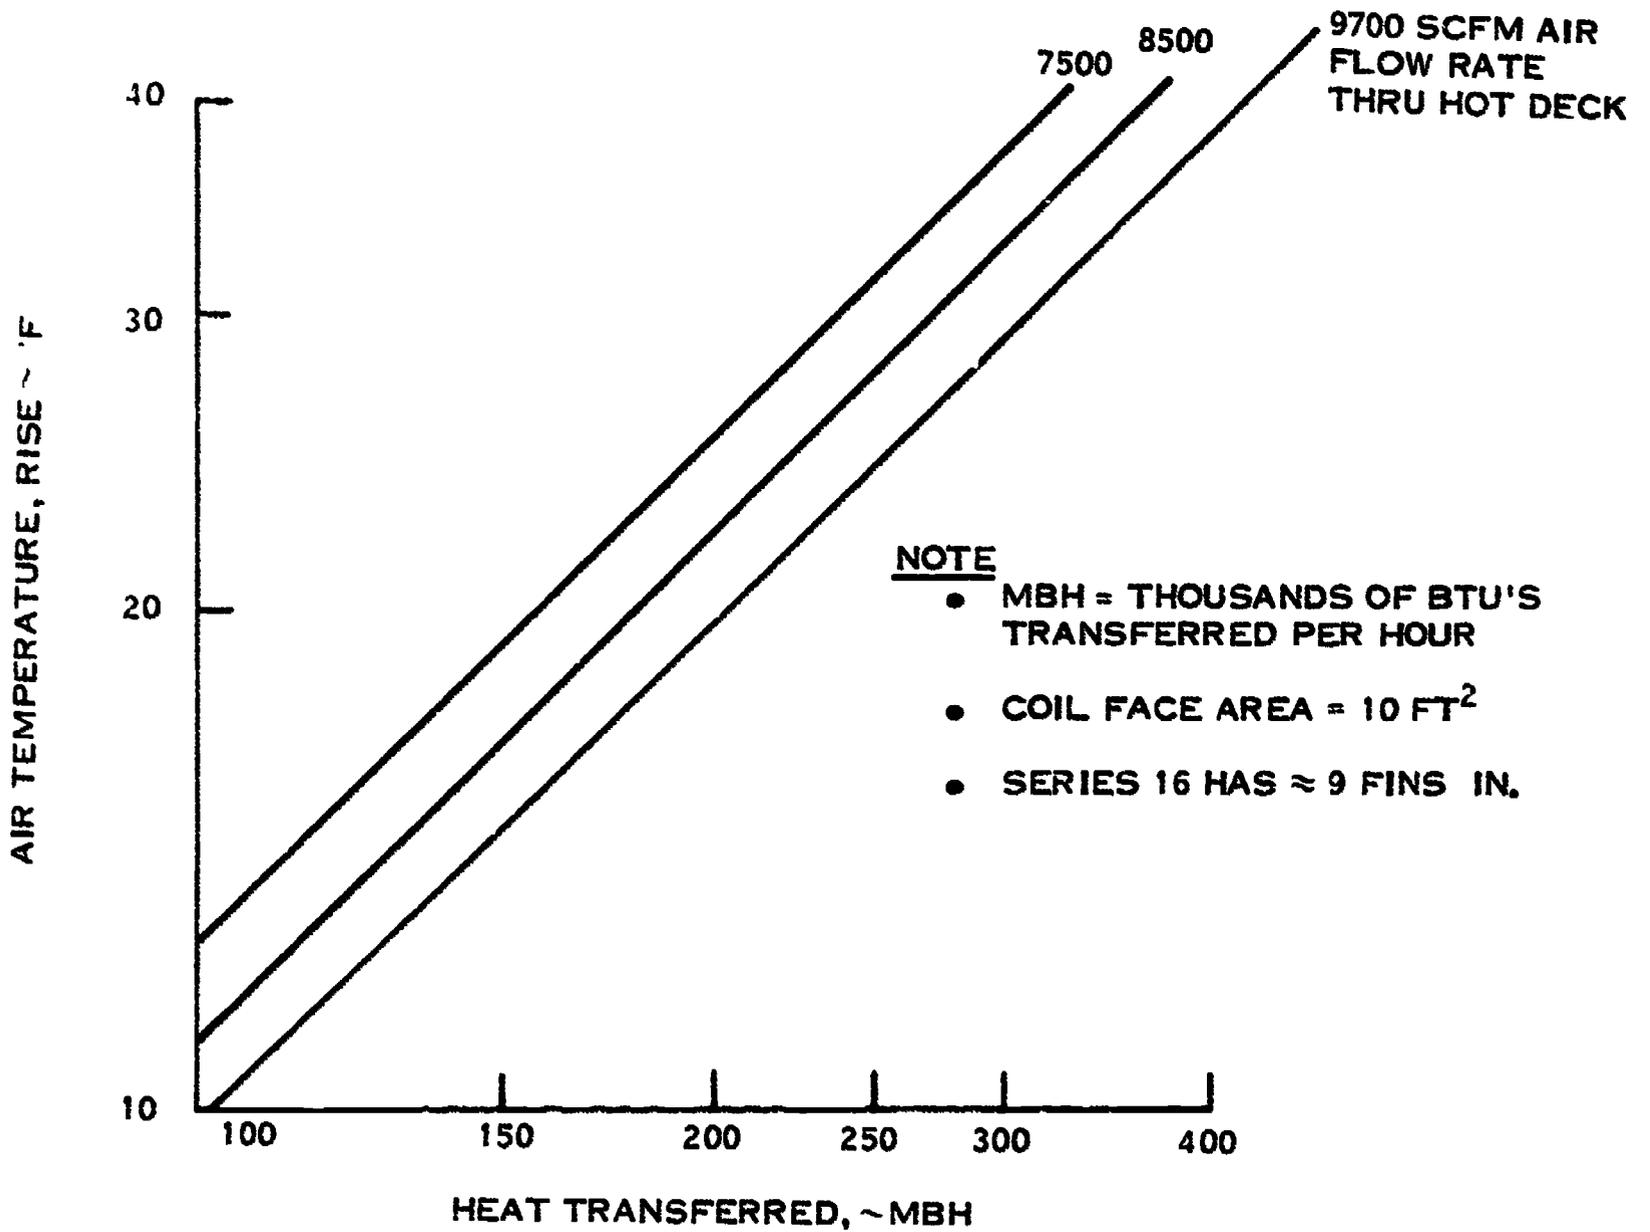
Figure 4-26. Predicted Heat Transfer Characteristics Based on Air Side Data for Water/Glycol Coil

TRANE, SERIES 16, TYPE W, TWO ROW

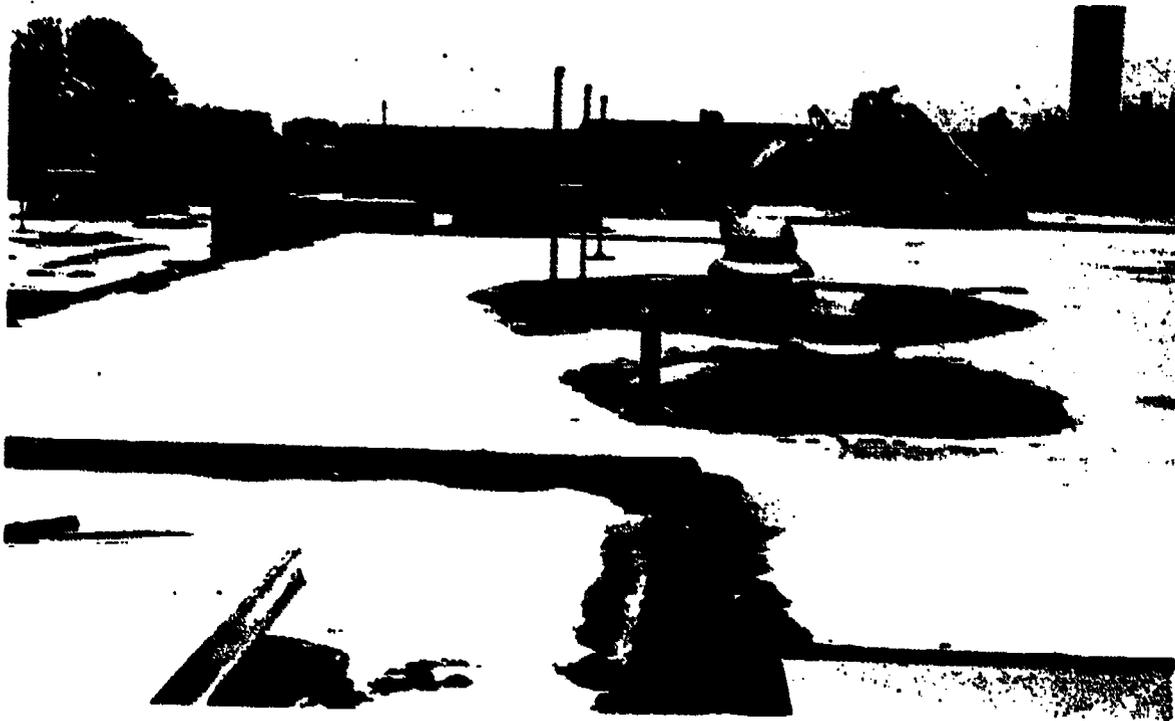
Figure 4-28. Roof Ventilators, Rear Row

Various types and locations for such an auxiliary heat exchanger were available; one type being simply a fan/coil unit of the appropriate capacity. However, an observation made during the initial inspection tour and which is visible in Figure 4-7 led to a dual function unit. The roof mounted ventilators represent a significant heat removal from the school — this is not unusual since schools by design intent have large rates of air exchange. A qualitative indication can be seen as the melted snow around three of the ventilators shown in Figure 4-7. A closer view is shown in Figures 4-28 and 4-29. The morning the pictures were taken it was between 6 and 10° F with almost no wind and the exhausting warm school air had both melted the previous day's snow and, in spots, dried the roof. Figure 4-28 shows a view looking east along what will become the rear or north row of collectors, and Figure 4-29 shows a view also looking east along what will become the center row of collectors. These three ventilators shut off only at night and provide a steady flow of 70 to 75° F air. The near and far ventilators in Figure 4-28 operate at 1050 and 2750 cfm, respectively, and the unit shown in Figure 4-29 operates at 1575 cfm.

The dual function concept then is to form a heat exchanger around these ventilators, use the steady source of air to cool the loop for the heat dump mode, and also use the steady source of warm air to accelerate the morning warm up transient. Since it is reasonable to expect the loop working fluid to start out the morning at temperatures ranging from 0 to 30° F in winter, this warm air supply represents a significant boost. A discussion of how the control system functions to accomplish this is given in Section 4.2.4.

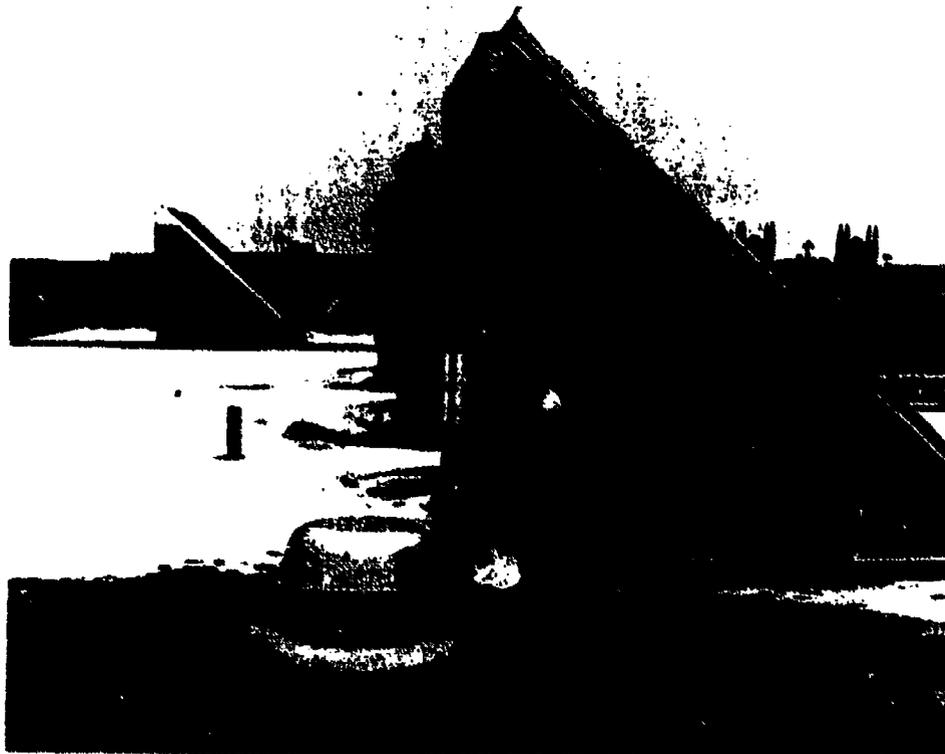
Figure 4-29. Roof Ventilators, Center Row

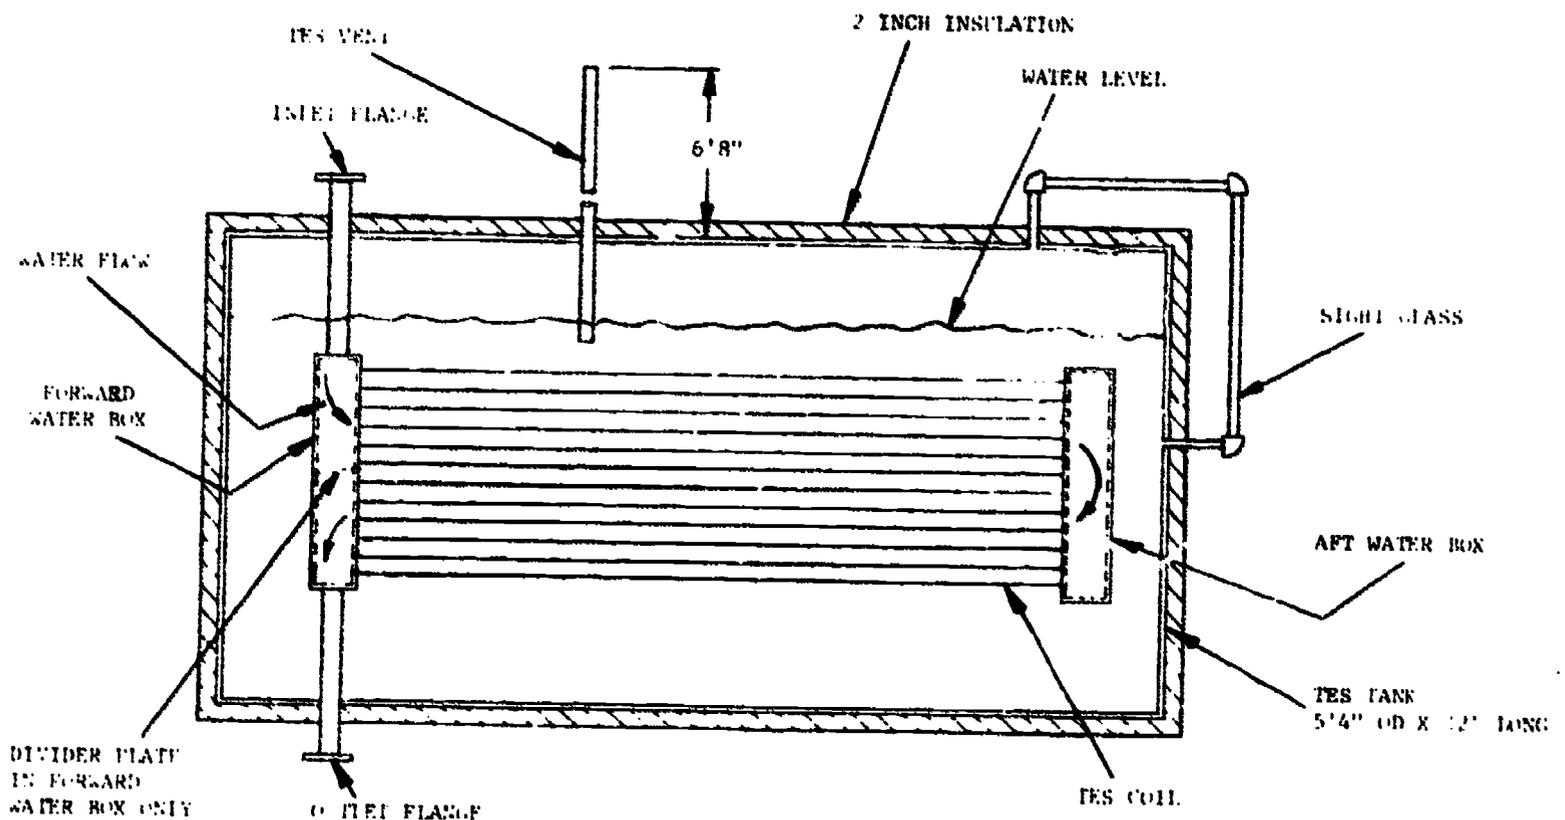
**Figure 4-31. Cross Section Pictorial of Thermal Energy Storage Tank**

As a result, the main loop is circulated within the relatively high pressure coil and the coil is in turn submerged in a stagnant tank of liquid. A schematic of the general configuration is shown in Figure 4-31. The stagnant layer of liquid surrounding the coil will thermally stratify but the consequences of this are somewhat negated by routing the main loop fluid in through the top and out the bottom of the tank. As mentioned in the control system discussion of Section 4.2.4, when energy is being withdrawn from the TES tank, the flow through the coil is reversed; entering in the warm bottom region and leaving from the hot upper region.

The principle design problem is to minimize the so called approach temperature. This is defined in this case as the temperature differential between the main loop and the stagnant TES fluid. While it is a bit of an oversimplification, the significance of the approach temperature is that it limits the maximum temperature available when heating the school from the TES tank. This occurs because there is a temperature drop from the main loop to the TES fluid during the storage mode and there is also a drop from the TES fluid to the circulating fluid in the withdrawal mode. Since the heat transfer rates are likely similar and the two temperature drops are additive, the maximum temperature available to heat using TES is the maximum main loop temperature less twice the approach temperature.

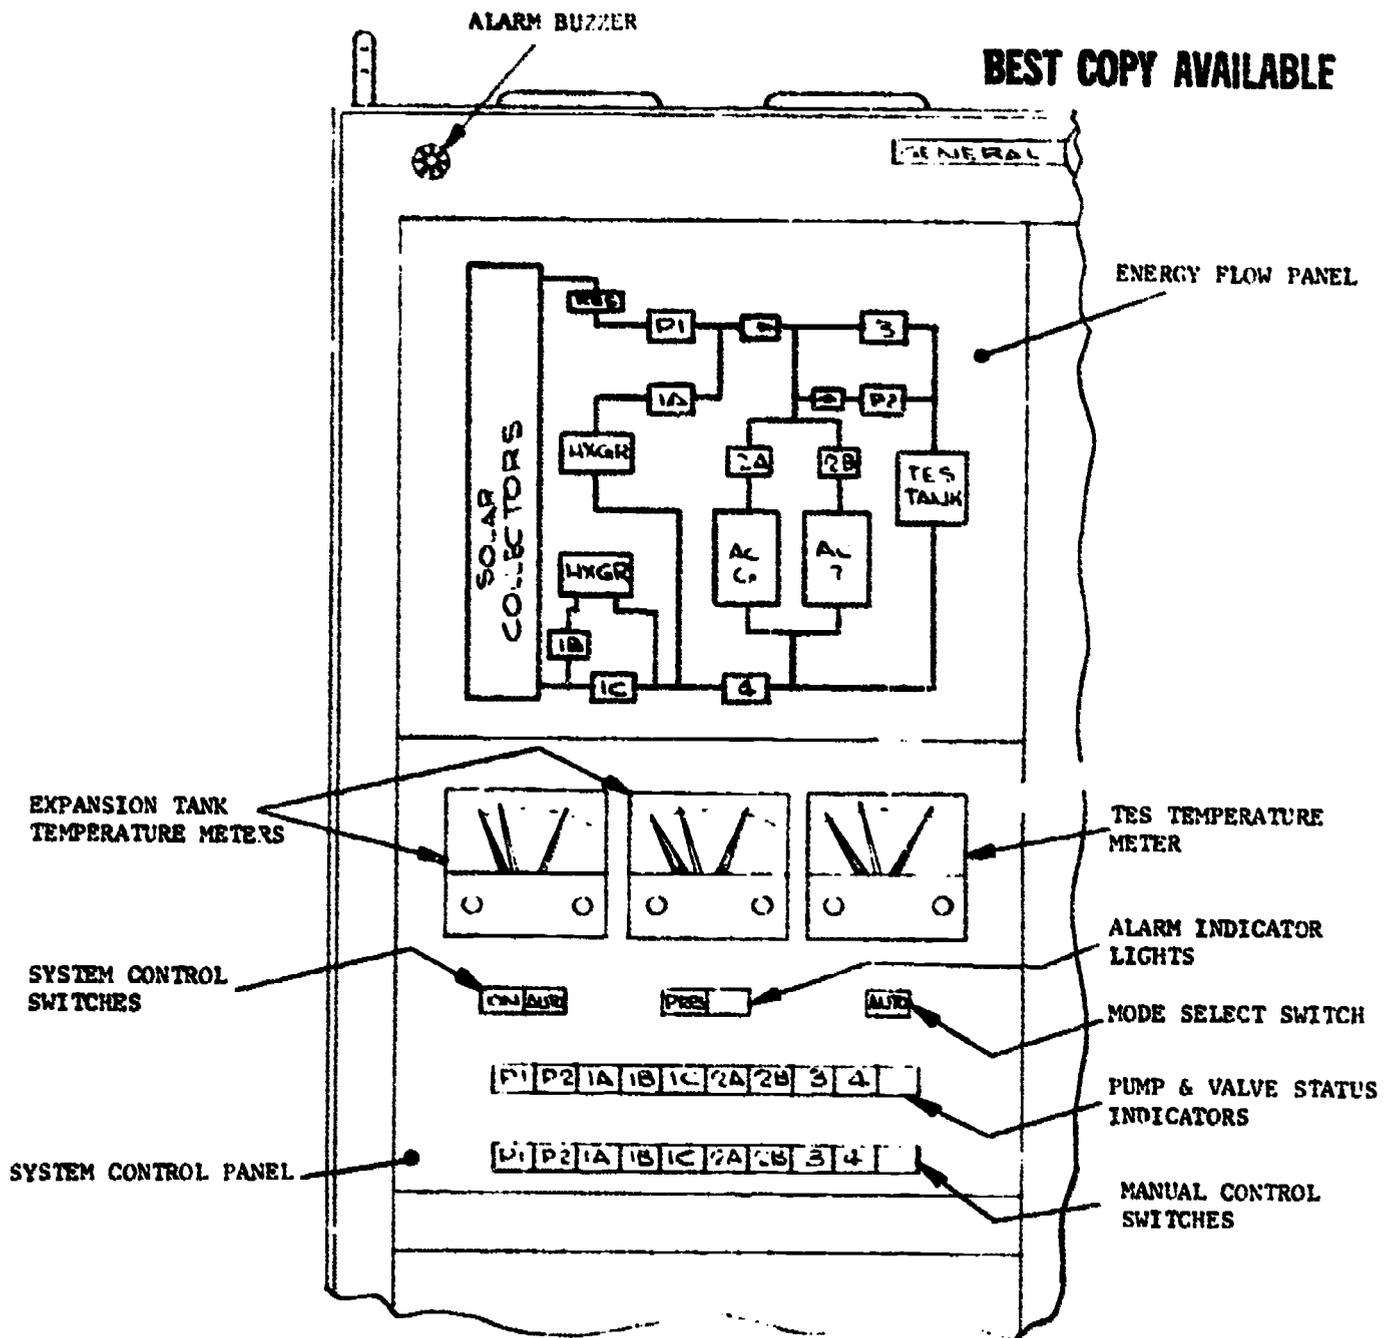
Figure 4-34. Control Portion of Console

The system normally operates in a fully automatic mode with the 24-hour time clock shutting the system down during nighttime.

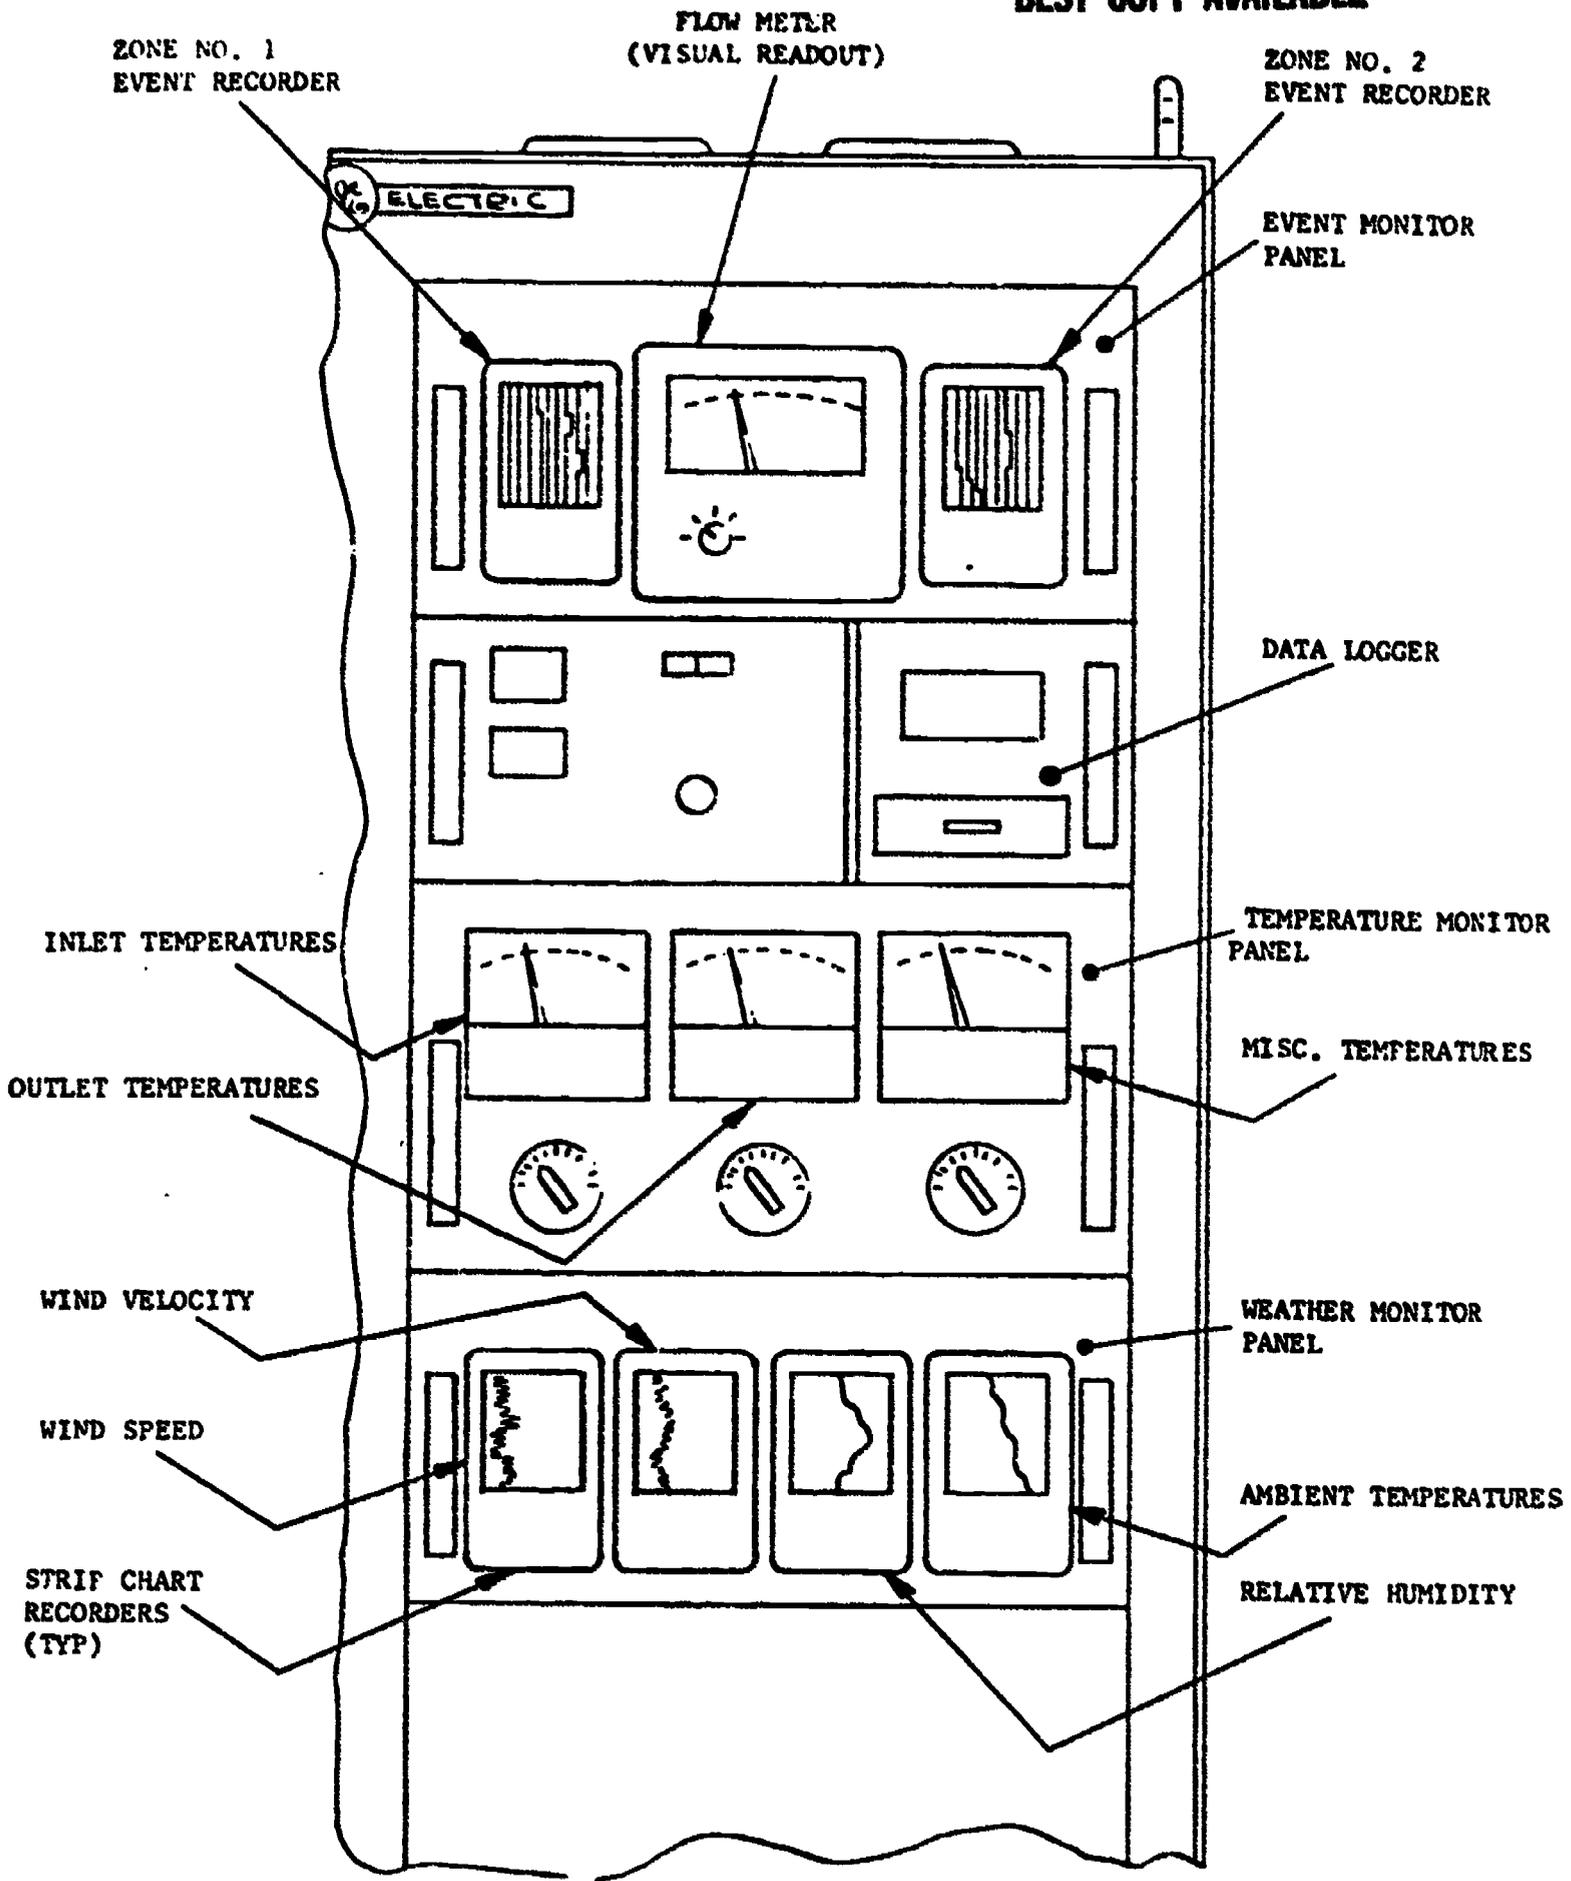
Figure 4-36. Data Acquisition Portion of Console

The sampled data is the primary data source for analysis of the system. It consists of 90 channels of copper constantan thermocouple data, nine channels of millivolt analog voltages and one calibration reference voltage for a total of 100 channels. Useage of thermocouples with the datalogger as opposed to other temperature measuring devices, eliminated compensation for lead lengths, calibration as installed, and susceptability to power supply fluctuations. In addition, premium thermocouple wire with a guaranteed accuracy of  $\pm .75^{\circ}\text{F}$  was utilized and was routed along the steel support structure and through dedicated conduits. This provided such an effective electromagnetic shield that no "noise" was discernable even on the longest leads when a neighboring elevated train passed. The 100 channels of data are recorded sequentially on printed paper every 30 minutes which is a marginal frequency for insolation but adequate for the other data. There is approximately a two day supply of paper in the datalogger and, as a consequence, the school custodian periodically both annotates and reloads the datalogger paper. The first two millivolt channels are utilized for solar flux and loop flow rate and Channels 3 through 9 are unallocated presently. Channels 10 through 75 are various system temperatures and Channels 76 through 99 are detail temperatures obtained from within four instrumented collector panels. A detailed list is provided in Table 4-4.

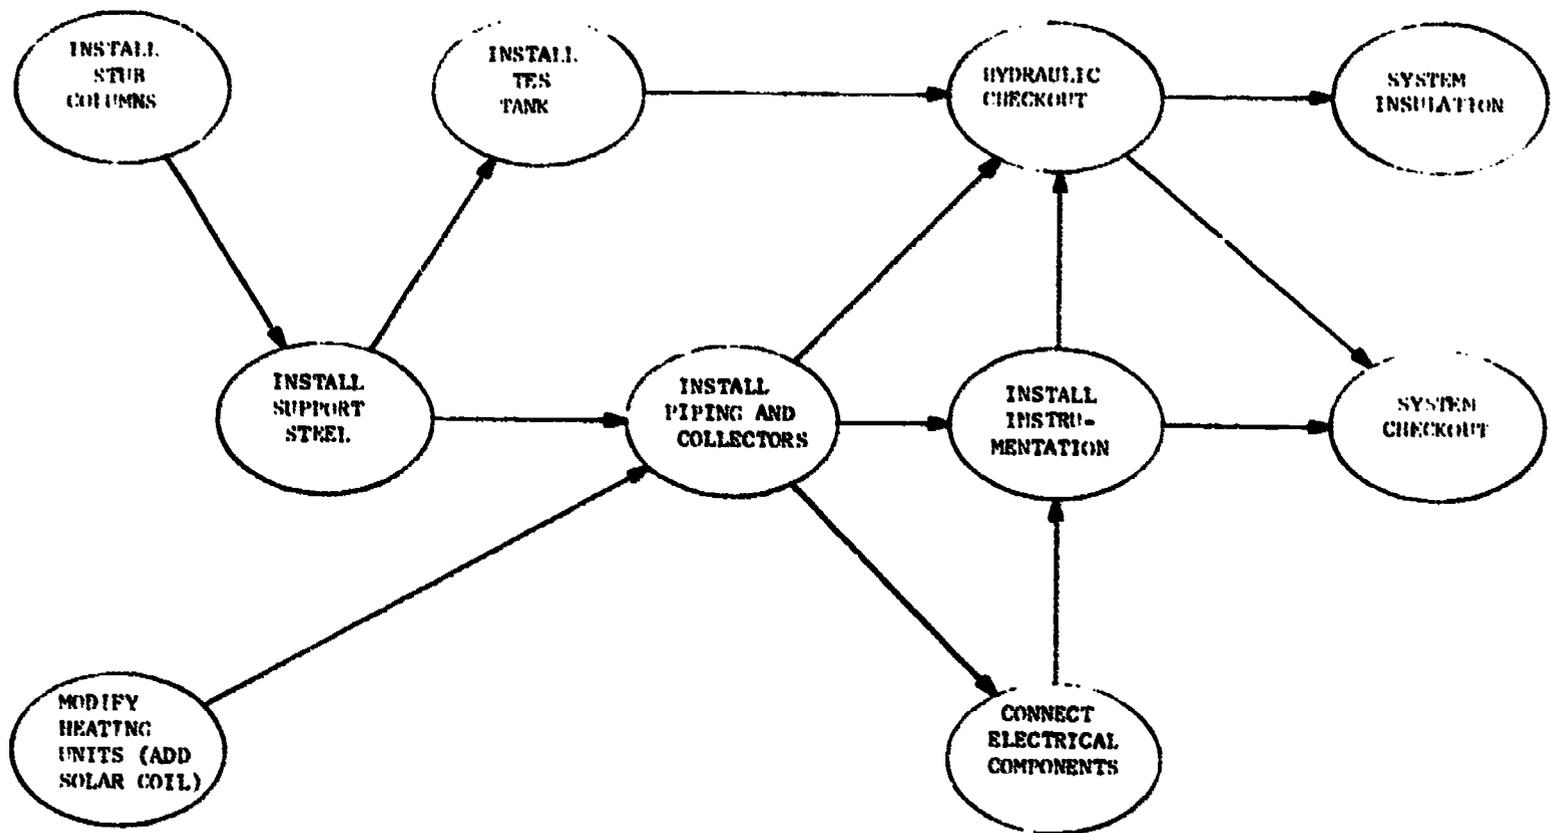
Figure 5-2. Relationship of Installation Tasks

The overall schedule for this phase was given in Figure 5-1. The relationship of the various activities is shown in Figure 5-2.

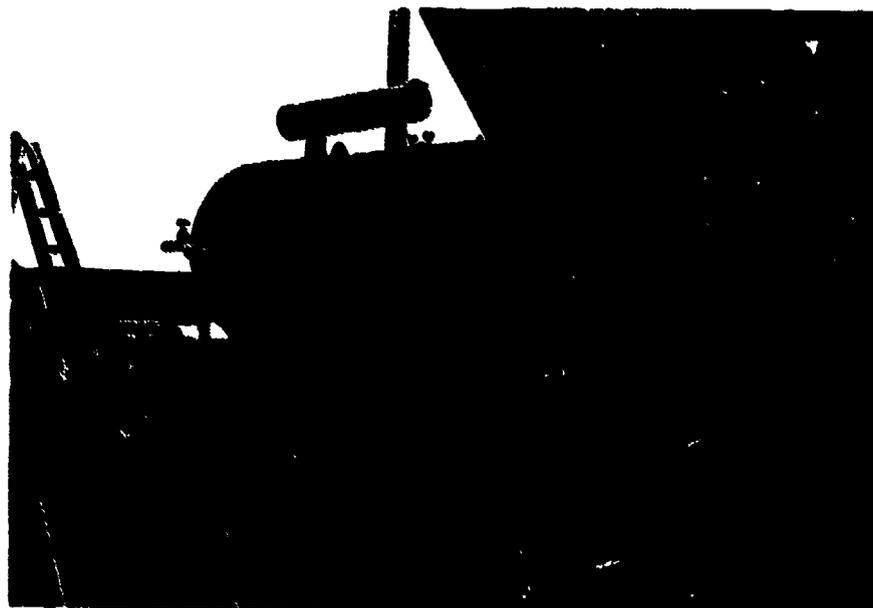
Figure 5-15.

The TES tank at approximately 4500 pounds was one of the heavier individual lifts. Figure 5-14 shows the tank set in place behind the center row support steel and Figure 5-15 shows it with the piping in progress.

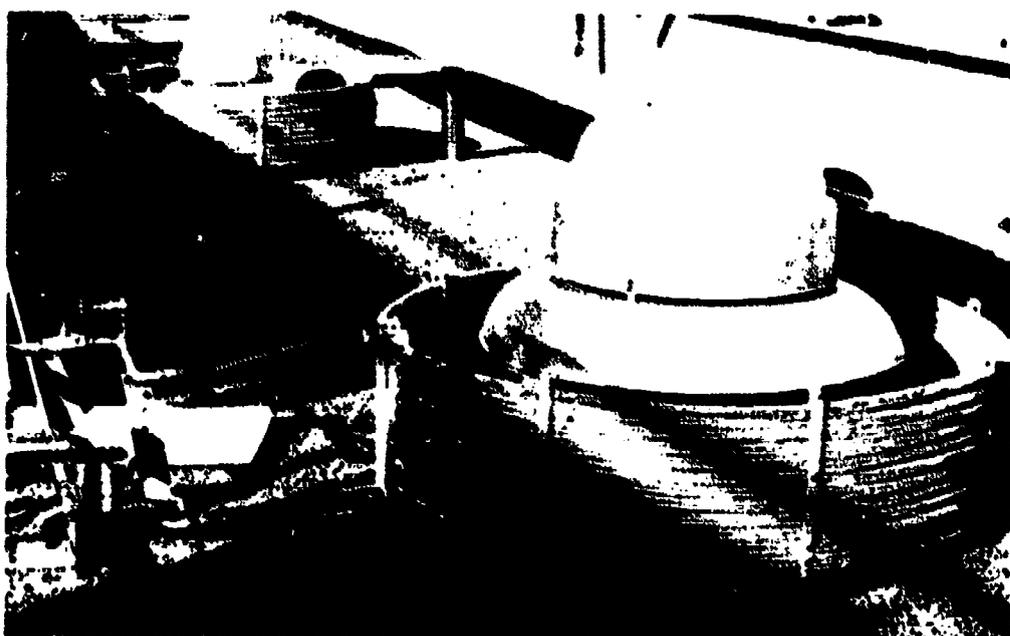
Figure 5-16.

The bypass heat exchangers were also installed in this time frame. Figure 5-16 shows the two main coils in place around the ventilating blowers, but without the conical covers in place. The conical cover was made up in Boston based on "as installed" dimensions to insure a good fit. Rubber hose was utilized to connect the aluminum coils to the copper piping to preclude direct copper/aluminum contact and minimize the likelihood of galvanic corrosion. The hoses

shown in Figure 5-16 did not prove adequate, and had to be replaced with a reinforced version. Figure 5-17 shows the finished installation.

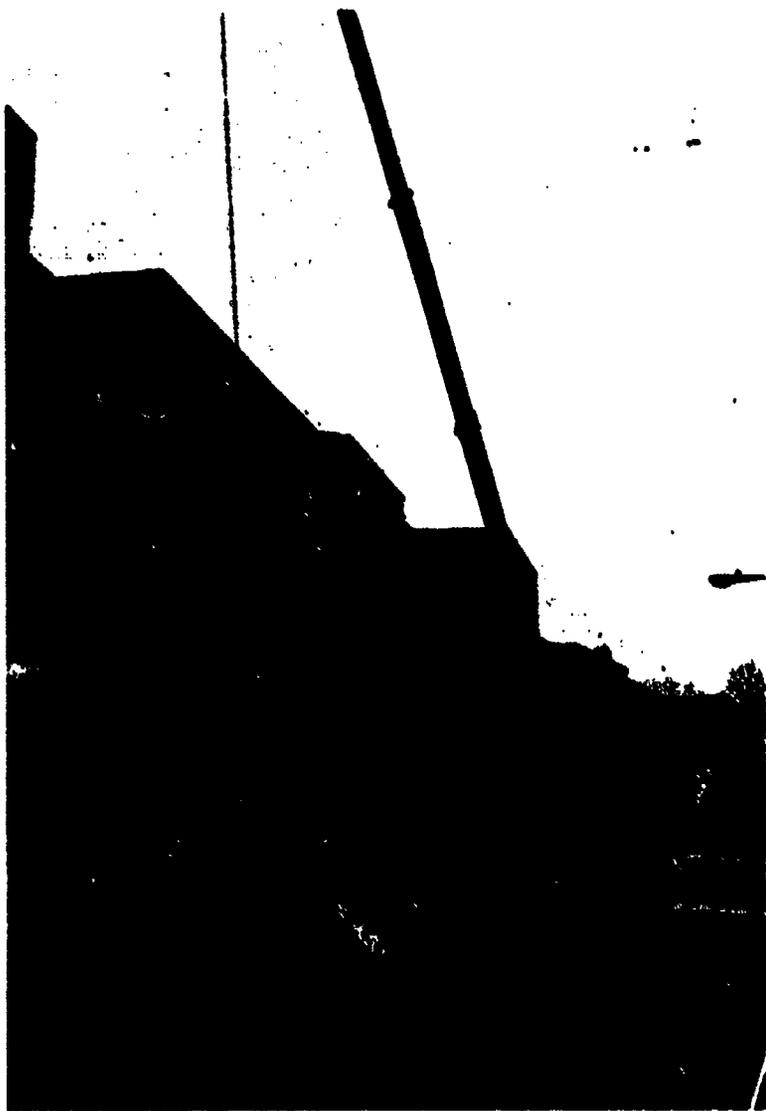
The collector panels were shipped to the site in specially made reusable crates, each holding 10 collectors. The loaded crates had a gross weight of about 1400 pounds and were hoisted onto the roof using a small crane as shown in Figure 5-18. The collectors themselves were covered with black polyethylene as the last operation of final assembly. This was done to minimize the absorber plate temperatures which would be experienced during installation prior to initiating water flow. Black polyethylene was less desirable than white for the purpose but was more available. The collectors assembled late in the program utilized clear polyethylene over white "butcher paper." Figures 5-19, 5-20, and 5-21 show collectors being removed from the crates, carried to the center row of steel, and slid into position. Since the collectors weigh nominally 100 pounds apiece, these operations can be done by two men; however, three were frequently used to facilitate guiding the panel into position over the pre-drilled mounting holes. The upper panels were somewhat more difficult to install due to the height inconvenience as typified by Figure 5-22. The first bank installed (Bank B) in its nearly complete state is shown in Figure 5-23.

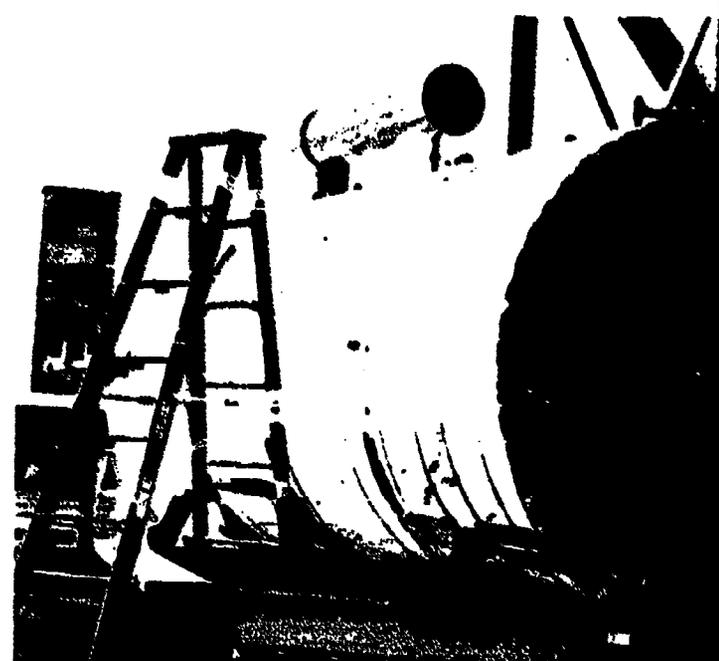
Figure 5-28.

Insulation was normally the last physical act of installing on a given section of the system. Of necessity, it had to follow both the leak check and instrumentation operations. The insulation consisted of a semi-rigid fiberglass sleeve with a protective aluminum sheath being applied over top of it for straight runs of pipe. All fittings were insulated with fiberglass batting encased in formed to fit, protective plastic sheaths. The flow balancing valves and connecting hoses to the collectors were left uninsulated since it appeared the cost and resulting complication were not warranted by the potential heat saving. The TES tank was insulated in the same manner as the pipes except that two inches of insulation were utilized and the ends were plastered with a mastic compound to provide a weather seal. This is shown in progress in Figures 5-28 and 5-29.

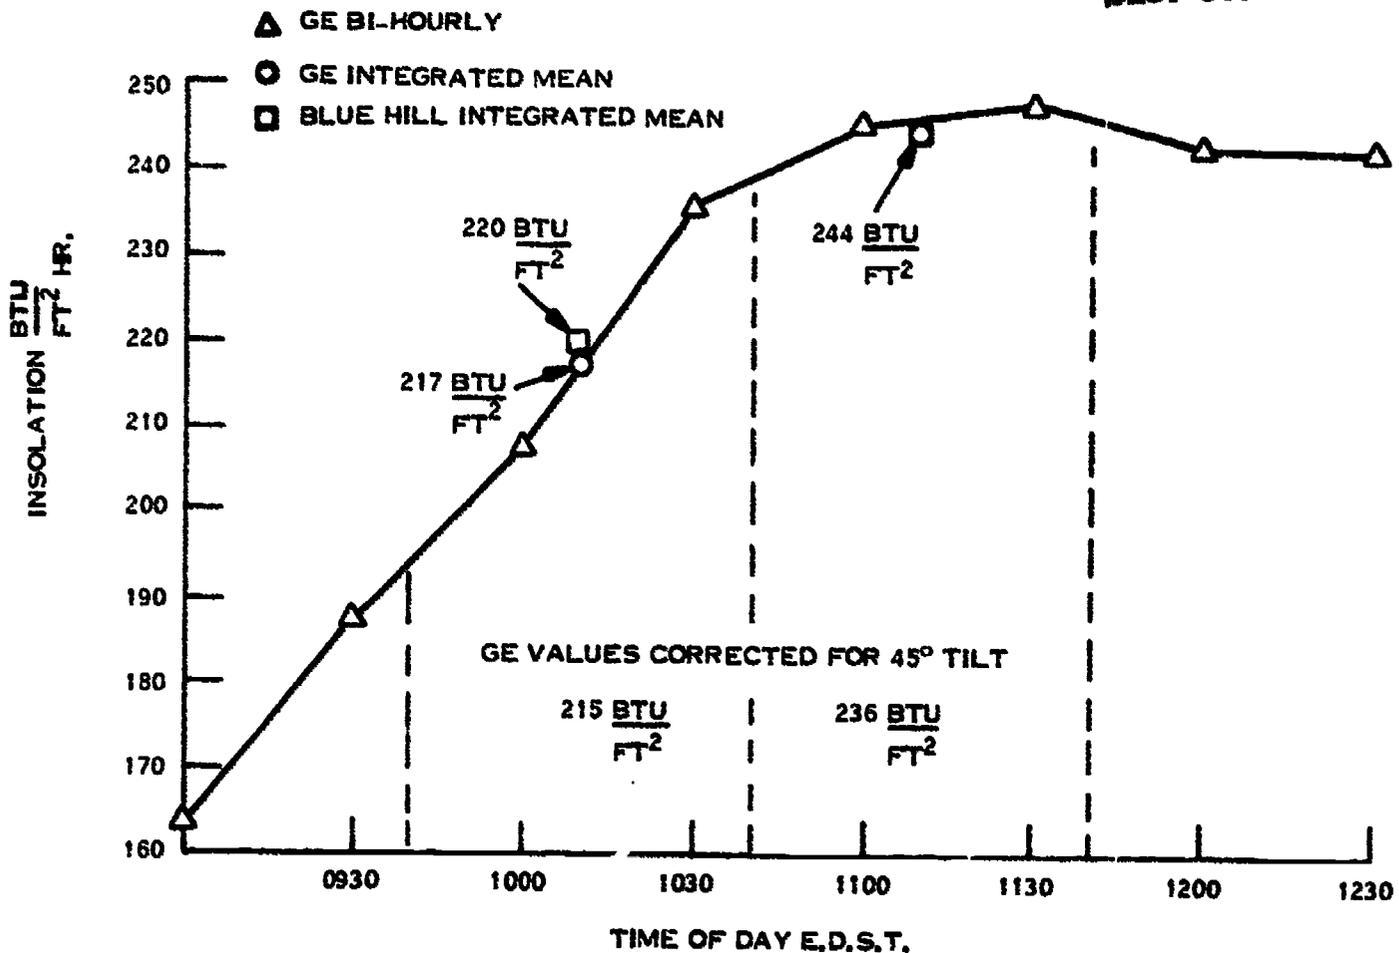
Figure 6-44. GE Pyranometer Data

Reference 2 "Availability of Solar Energy for Flat-plate Heat Collectors" by Benjamin Y. H. Liu and Richard C. Jordan and Published in Low Temperature Engineering Application of Solar Energy by ASHRAE, 1967.
