# SATELLITE TECHNOLOGY DEMONSTRATION

TR0421

STD INSTALLATION AND MAINTENANCE PROCEDURES

BILLY D. LANE

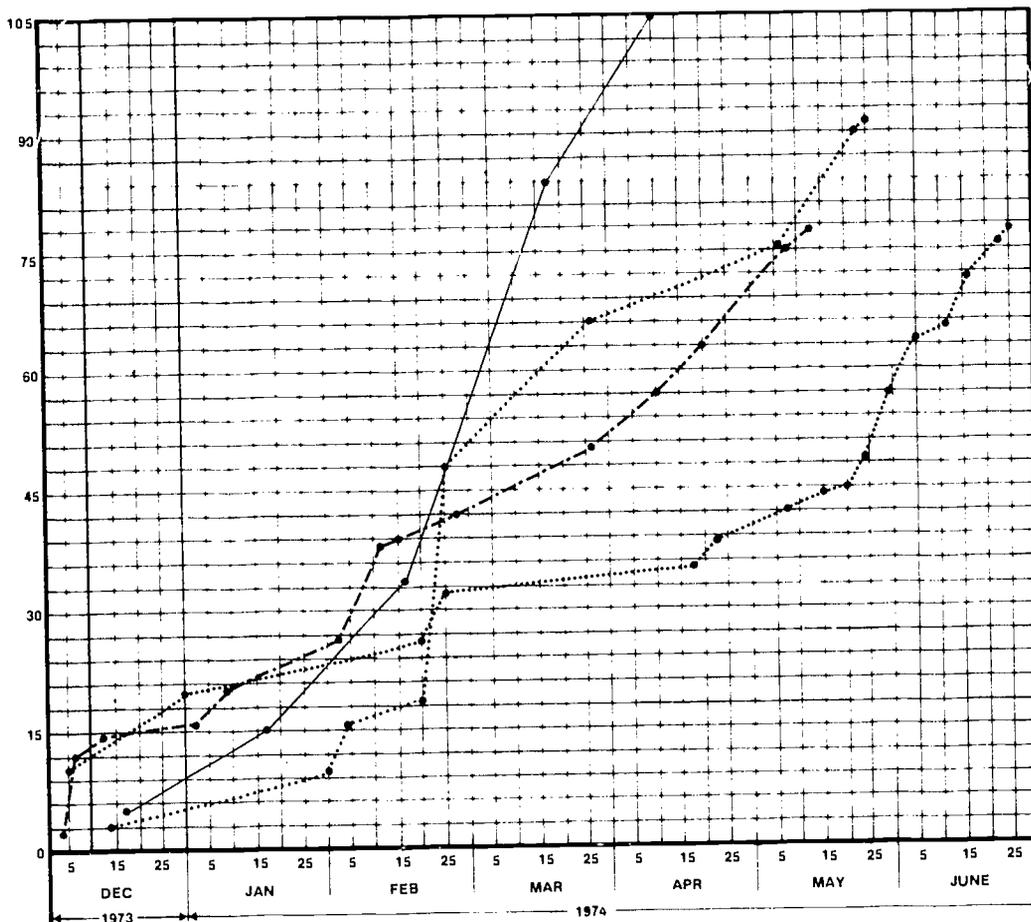
——— CONTRACT SCHEDULE  
 ..... RECEIVERS  
 - - - REFLECTORS  
 - · - MOUNTS FEEDS CABLES

NOT INCLUDED ARE ELEVATION MOTORS  
 AND ASSOCIATED CABLES. FIRST UNIT  
 RECEIVED OCTOBER, 1974.

But to make the installation in one trip, the crew needed a complete set of parts from Westinghouse. Unfortunately, this did not happen. Figure 1 shows that the ROT components came in three widely separated shipments: First came the mounting hardware for the reflector; then, the electronics; and finally, the segmented reflector.
