AUTHOR Sampson, Foster K.
TITLE Contrast Rendition in School Lighting.
INSTITUTION Educational Facilities Labs., Inc., New York, N.Y.
REPORT NO TR-No-4
PUB DATE Jan 70
NOTE 103p.
AVAILABLE FROM Educational Facilities Laboratories, Inc., 477
Madison Avenue, New York, N.Y.

Eighteen significantly different classroom lighting systems were measured and analyzed in order to determine how contrasts from different light sources affect the ability to see visual tasks in the school room. Using criteria and techniques established from previous lighting research, the lighting systems are evaluated according to their characteristics regarding contrast rendition of pencil handwriting. The comparisons and conclusions presented should be helpful in selecting classroom lighting systems.

Contrast Rendition in School Lighting

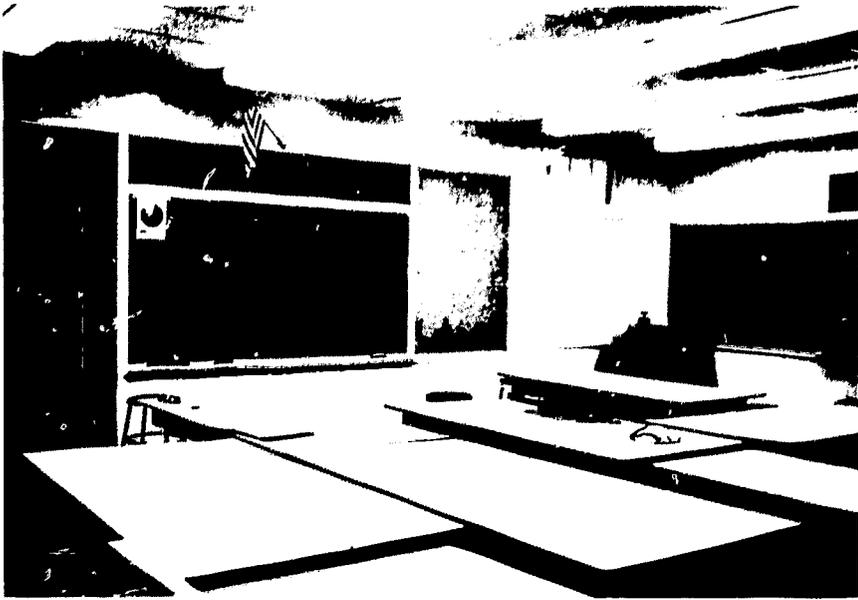
Location	Electric	Footcandles	
		Daylight	Combination
1	69	24	93
2	66	28	94
3	57	25	82
4	75	37	112
5	74	63	137
6	69	37	106
7	66	90	156
8	60	160	220
9	51	46	97
10	78	30	108
11	72	29	101
12	72	105	177
13	66	90	156
14	45	66	111
15	51	36	87
16	51	45	96

The ESI values are all fairly low in spite of good CRF, and this is due to the low level of the general lighting. The difference between M1 and M2 is reasonably small, no doubt due to the relatively close spacing of the rows. Although the difference between M1 and M3 is very small, this is some indication that rows of luminaires transverse to the line of sight cause somewhat less loss than those in line. This is also verified in Project 3.

The addition of daylight makes a remarkable improvement in the ESI where the line of sight is away from, or at right angles to, the direction of the windows. No readings were taken to simulate children looking towards windows because the veiling reflectances would be bad and the discomfort even worse.

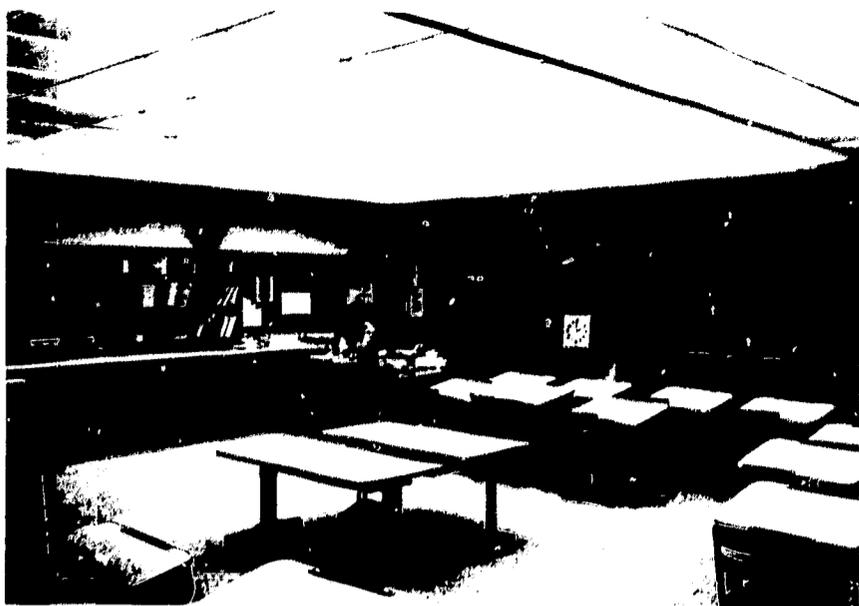
Location	Daylight	Day and Electric
1	.4	69
2	.8	79
3	.8	66
4	.6	105
5	1.6	120
6	1.5	96
7	.4	66
8	1.6	85
9	2.4	69
10	.6	102
11	.9	99
12	1.0	111
13	2.2	105
14	—	42
15	—	45
16	—	42

Only four projects had higher ESI values at the M1 position, and this project would have had a much better rating if three factors were different. The luminous portion of the ceiling should have been extended to the wall to provide light on the wall. Also the wall colors above the chalkboard line should be nearly white, and all tackboards should have been as high in reflectance as possible. The effect of the extremely dark front wall is seen by the reduction of ESI value at M3 as compared with M2.

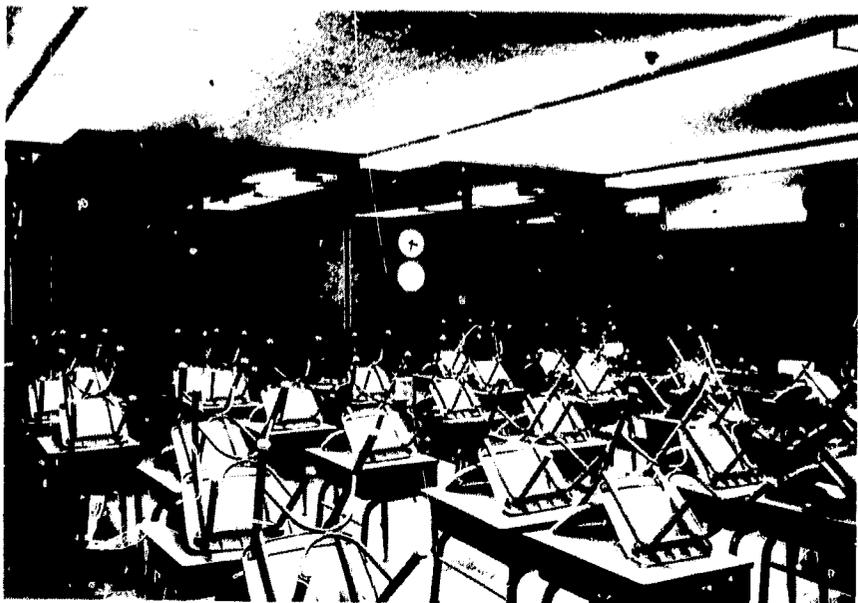
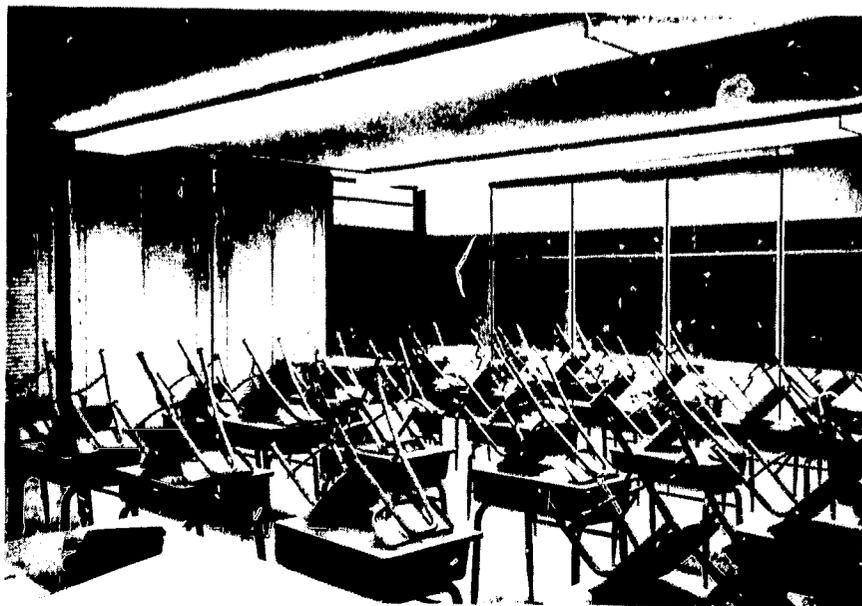
Station	Daylight Only	Footcandles		Daylight plus All Four Lamps
		Center Rows of Lamps	Outer Rows of Lamps	
1	4	81	84	169
2	1	114	117	232
3	1	81	81	163
4	2	98	99	199
5	1	129	128	258
6	1	93	93	187
7	3	88	86	177
8	1	114	114	229
9	1	78	75	154
10	3	105	102	210
11	1	102	99	202
12	3	99	99	201
13	1	96	91	188
14	4	47	47	98
15	2	54	59	115
16	2	47	52	101

This project is one of the poorest of those measured, and demonstrates conclusively that the use of a relatively narrow luminaire in widely spaced rows will result in high loss of contrast. Even though this system produces 108 footcandles with two lamps per luminaire and 215 with four lamps, the CRF is poor in either case. This system demonstrates that the CRF is a function of the manner in which the light is directed to the task, not the level of illumination. The outside pair of lamps produce a slightly higher CRF than the inside pair for two reasons: the inside pair results in a narrow light source when compared with the wider spacing of the outside pair plus the light on the ceiling, which is not present with the inside pair.

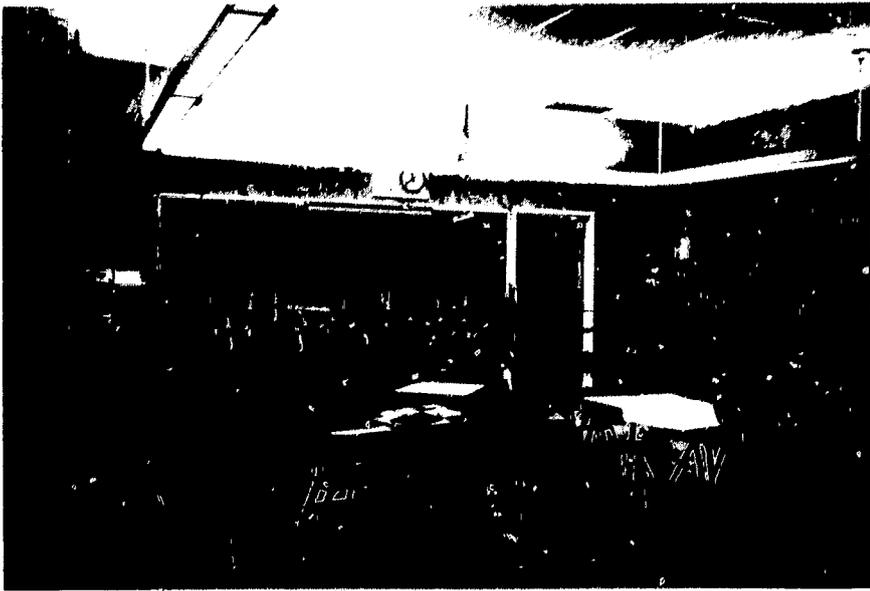
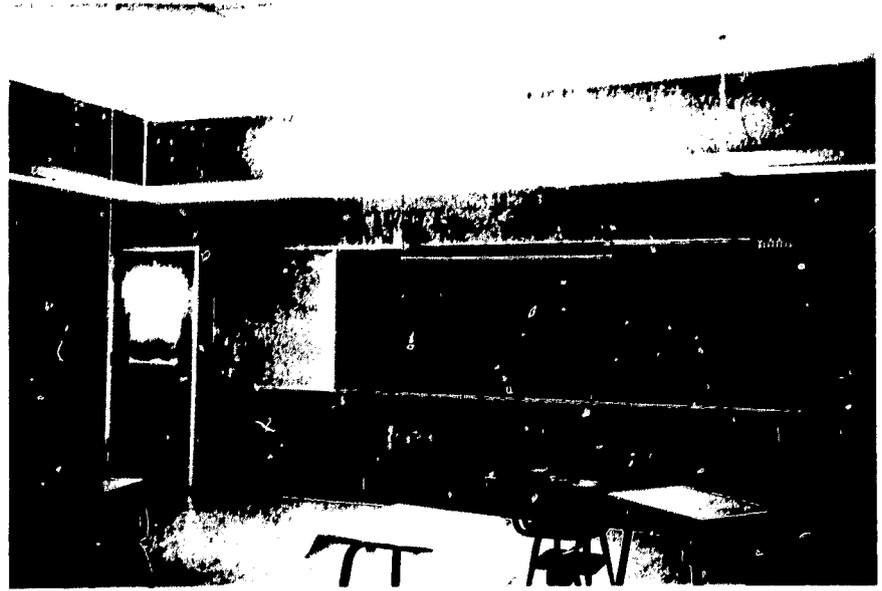
Location	Daylight	Footcandles Electric	Combination
1	17	68	85
2	20	69	89
3	14	73	87
4	26	69	95
5	28	54	82
6	20	74	94
7	39	65	104
8	43	63	106
9	31	72	103
10	21	72	93
11	18	72	90
12	39	66	105
13	35	72	107
14	43	34	77
15	48	37	85
16	33	44	77

The large windows are under a high corridor roof about 10'-0" wide. As a result, the afternoon sky provided a rather low level of added light in the room, but the CRF values were exceptionally good. At M1, daylight alone provided a CRF of 18% better than glare-free. If all students faced away from the windows, only the teacher would suffer from the extreme brightness.

CRF and ESI values are given for each of three lighting combinations, first electric, then daylight alone, and then a combination. The electric system is the number two system of all those surveyed in that it shows a 1.02 CRF and with only 59 footcandles the results are equivalent to 68.5 footcandles. This is of course due to the fact that the major percentage of the light to the task comes from an area outside the critical zone for veiling reflectances. The daylight alone produces an excellent CRF of 1.18 and an equivalent of 117.8 footcandles with only 36 footcandles. Here again most of the light reaches the task from the sides and behind; a small portion of the total originates from areas forward of the task. Where students can be placed with their backs to the windows, the CRF will be excellent, but the teacher will have a constant major glare source from the windows as she faces the class.

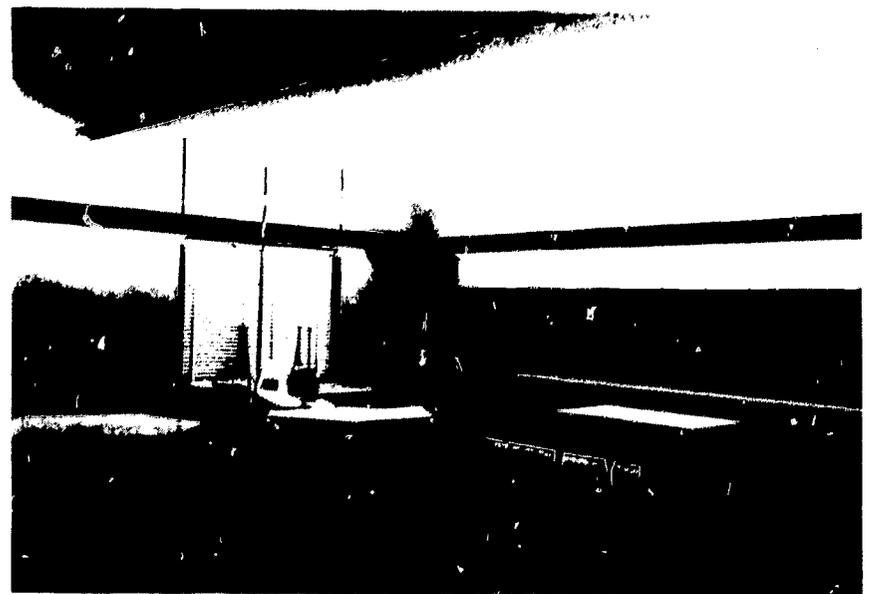
Location	Footcandles Electric
1	44
2	45
3	43
4	37
5	23
6	41
7	26
8	14
9	26
10	40
11	42
12	24
13	27
14	50
15	43

The excellent results shown in this project, in spite of several unfavorable conditions, would indicate that designers should recognize desirable aspects and work out cove systems to utilize their advantages. It appears that with proper ceiling shape and color, better wall reflectance, and a little more light, the CRF and ESI could be developed economically in spite of the inherent low lighting efficiency of cove systems.

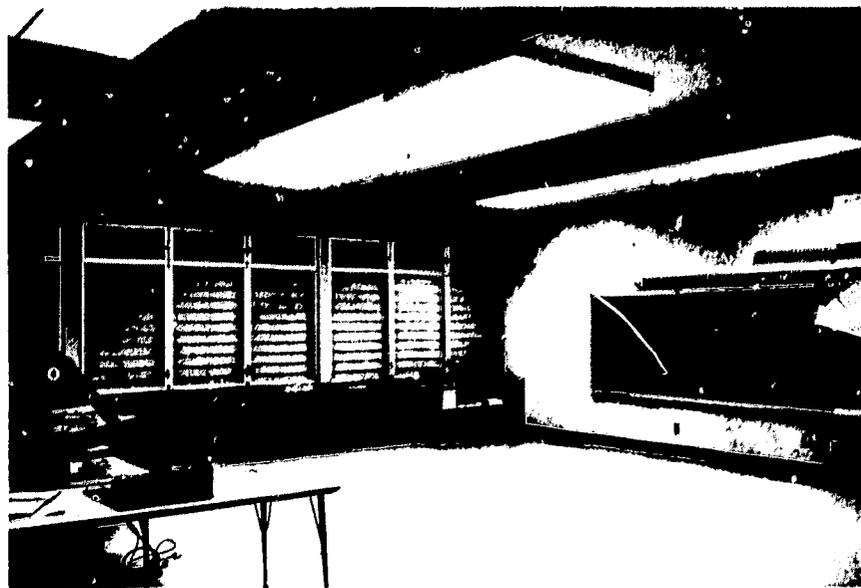
Location	Footcandles Electric	Location	Footcandles Electric
1	111	9	102
2	126	10	130
3	105	11	126
4	132	12	126
5	147	13	126
6	117	14	72
7	99	15	72
8	129

The brightness balance within the room is on the edge of being poor. In all systems using conventional recessed lenses, little or no direct light falls on the upper side walls or ceiling, and the floor is the primary source of reflected light to these areas. In this project, the floor has a reflectance of 40%, one of the highest of all those surveyed, and, as a result, the 80% ceiling has a brightness of 35 footlamberts. The room would have been better if the large areas of stained plywood had been of higher reflectance. The direct brightness from the lens was extremely high, and the brightness difference between the lenses and the adjacent ceiling was far above normal comfort limits.

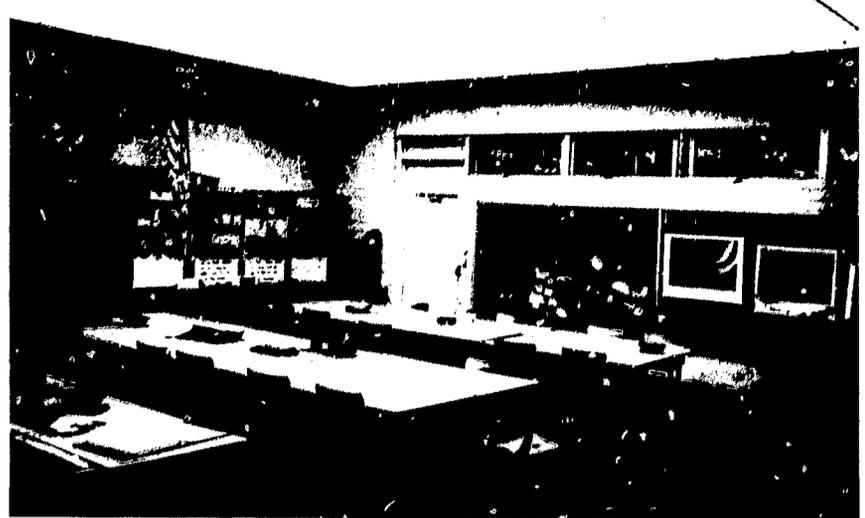
Location	Footcandles		Location	Footcandles	
	Daylight	Electric		Daylight	Electric
1	1.3	45	9	2.4	36
2	1.9	60	10	1.4	61
3	1.3	38	11	1.4	60
4	1.2	59	12	2.3	64
5	1.8	80	13	2.4	59
6	1.5	51	14	—	42
7	1.6	44	15	—	36
8	5.6	60

The CRF developed in this project would be the same for any nonpolarizing, diffusing material. The density of the diffuser may be high or low, but as long as the distribution characteristics are the same, the CRF will be the same. Although luminous ceilings were considered the ultimate in quality, this and the one in Project 2 do not prove the point. What this and other projects do prove is that, from the standpoint of contrast rendition, light from directly overhead is detrimental, regardless of brightness. The problem is how to direct light to the task from wide, low angles, rather than from directly overhead, and to do this without creating direct glare.

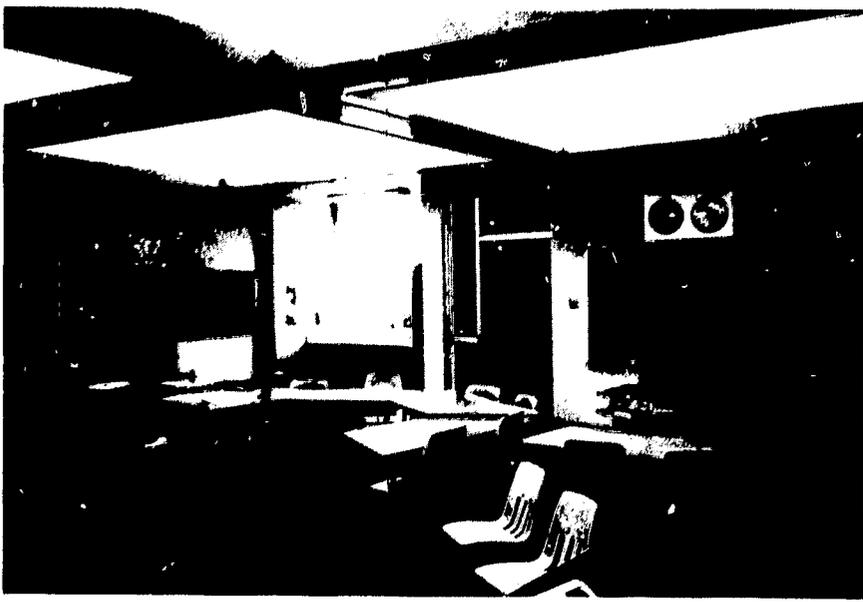
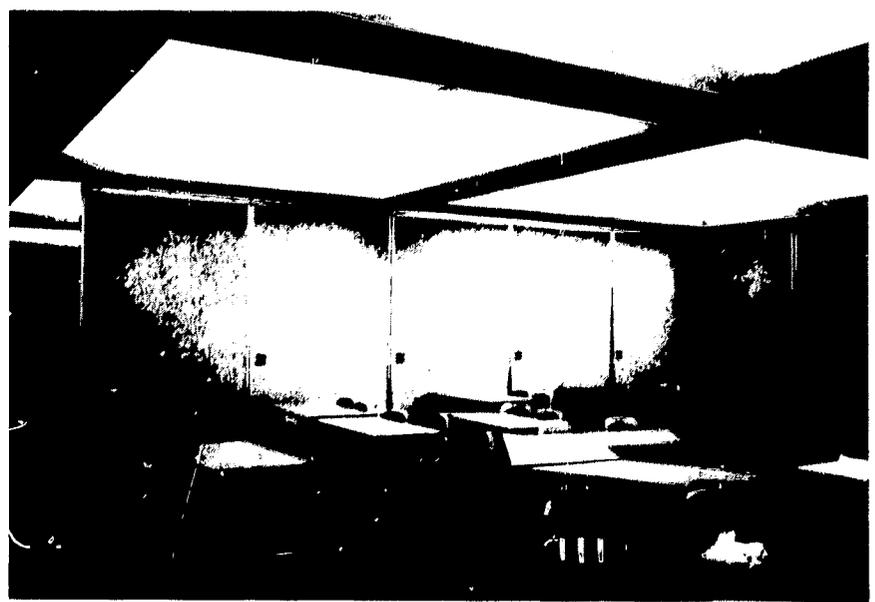
Location	Footcandles Electric	Location	Footcandles Electric
1	84	8	96
2	75	9	96
3	78	10	108
4	90	11	105
5	99	12	108
6	93	13	111
7	96	14	57

As would be expected, the CRF values in this project rate very well. The large areas of low over-all brightness produce diffuse light which minimizes veiling reflections. The side walls were all of high

reflectivity, and this added to the low angle light which is so advantageous. The normal practice of selecting the M1 meter position to reflect the center of a lighting panel produced the maximum brightness at the offending area. In this project, the center of the coffer has the lowest brightness, and for this reason the M1 position was moved forward three feet so that the ceiling area reflected in the task was about halfway toward the far side of the coffer. M2 was chosen at the same distance from the rear wall as M1, but on the center line of the room, under the 28" wide panel of ceiling, between coffers. This project has the third best CRF of those tested and should certainly arouse interest.

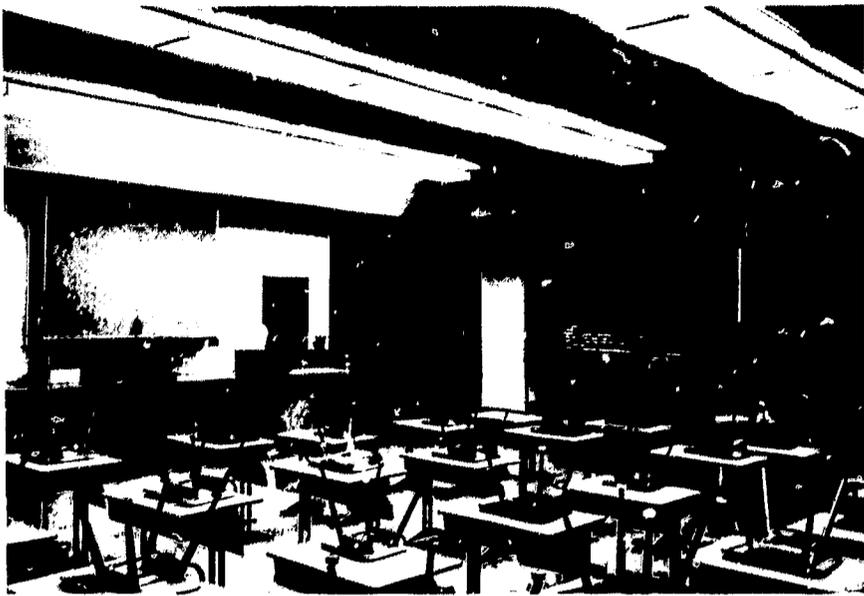
Location	Footcandles Electric	Location	Footcandles Electric
1	93	10	129
2	108	11	129
3	102	12	120
4	132	13	123
5	147	14	54
6	132	15	60
7	87	16	81
8	93	17	81
9	84

The CRF values are typical for continuous row systems, with narrow units. The CRF at M1 was poor, and 11 of the 18 projects had higher ratings. Added readings for 25° at M1 and M2 indicated the improvement in CRF by adding 36 foot-candles of daylight. The windows were directly behind the meter positions, and as long as all students face away from the windows, there would be a major benefit to those near the windows. Students farther from the windows would receive less benefit because of the smaller contribution of daylight. The direct glare problem has already been discussed in other projects.

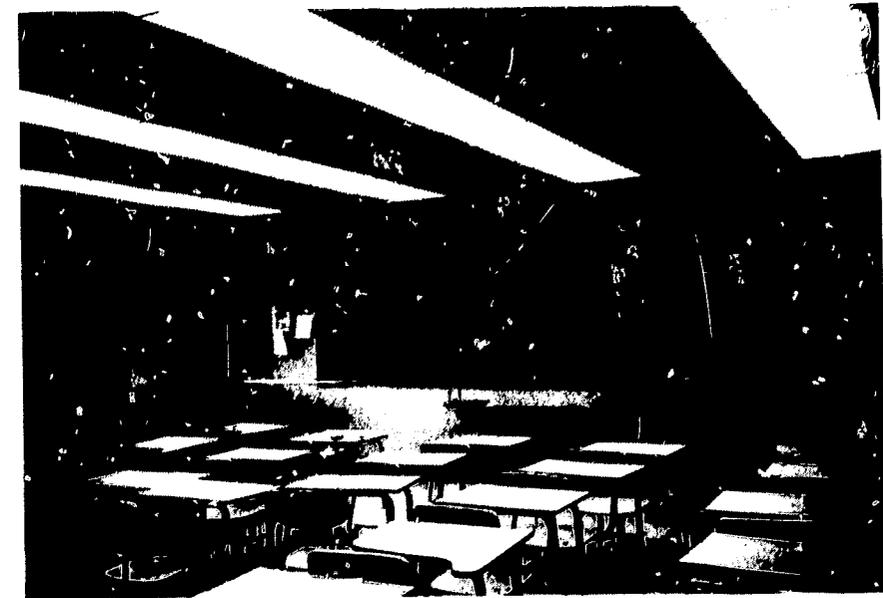
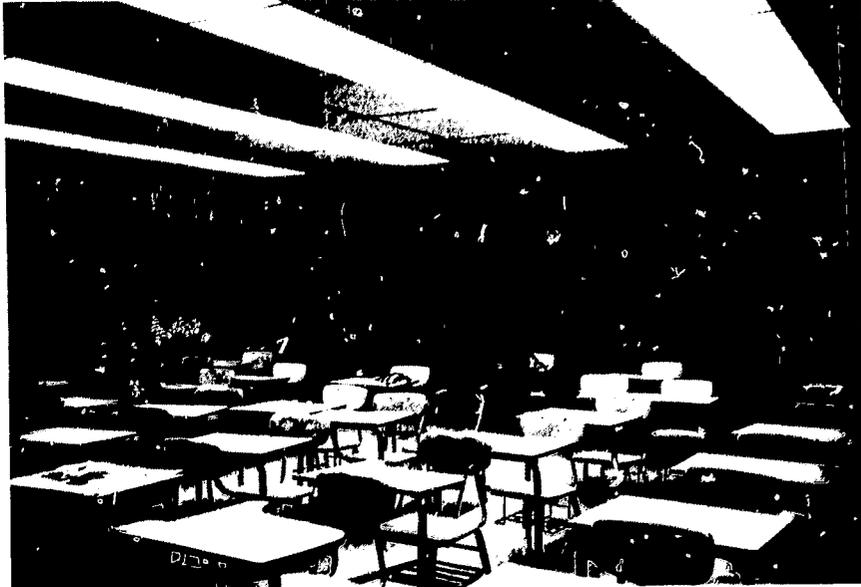
Location	Footcandles Electric	Location	Footcandles Electric
1	71	9	95
2	105	10	138
3	83	11	124
4	135	12	150
5	171	13	147
6	134	14	48
7	96	15	48
8	129

The CRF for this project is considerably better than Project 16 which used the 12" wide lens troffer.

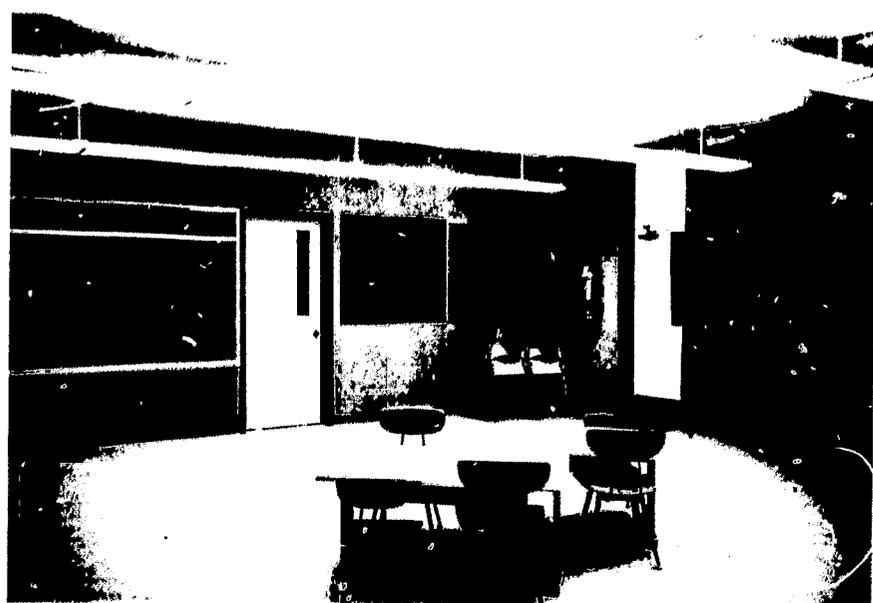
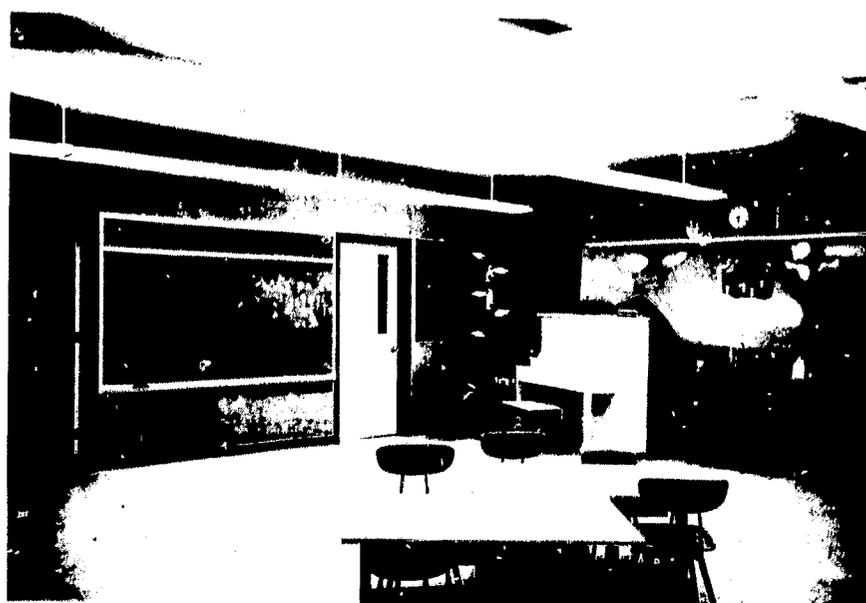
Location	Footcandles Electric	Location	Footcandles Electric
1	93	9	90
2	93	10	120
3	93	11	123
4	129	12	114
5	129	13	117
6	132	14	84
7	87	15	84
8	87

The levels of illumination shown on the table are a clear example of the desirability of splitting the six luminaires in each row, leaving at least four feet open, and thereby providing a higher level near the walls. The average would remain about the same, but the minimum level would be increased and the maximum reduced. The side wall colors are quite dark as compared to other projects, and this feature causes a loss in the over-all efficiency. This is more important in this project than in some of the direct systems, because a large portion of the light from the luminaires is directed to the ceiling and is in turn reflected to the work area. A large portion of the reflected ceiling light falls

At position M1, the task brightness was found to be 82 footlamberts, and, on this basis, 27 footlamberts should be the lowest acceptable brightness in any dark area. With the exception of the ceiling and lighting elements, there are very few areas, large or small, that come up to the desired minimum. Fortunately, the floors are exceptionally light, and this helped. In actual use, the room will have lower brightnesses because tables and chairs will cover a large portion of the floor, which was practically clear during the survey. The suspended luminaires provide a high component of light to the ceiling, and this tends to ease the discomfort from rather high fixture brightness.

The CRF value of .798 for this project is disappointing when compared with the .845 CRF found in Project 11 because the reverse condition might easily be anticipated. In Project 11, the room size is only slightly smaller, the walls are brighter, and the rows of luminaires are slightly closer together. In Project 13, the rela-

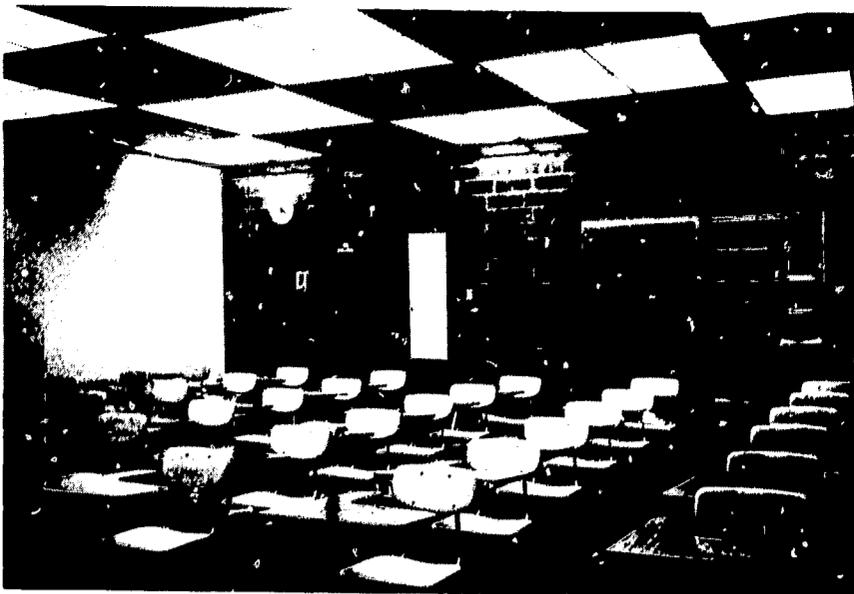
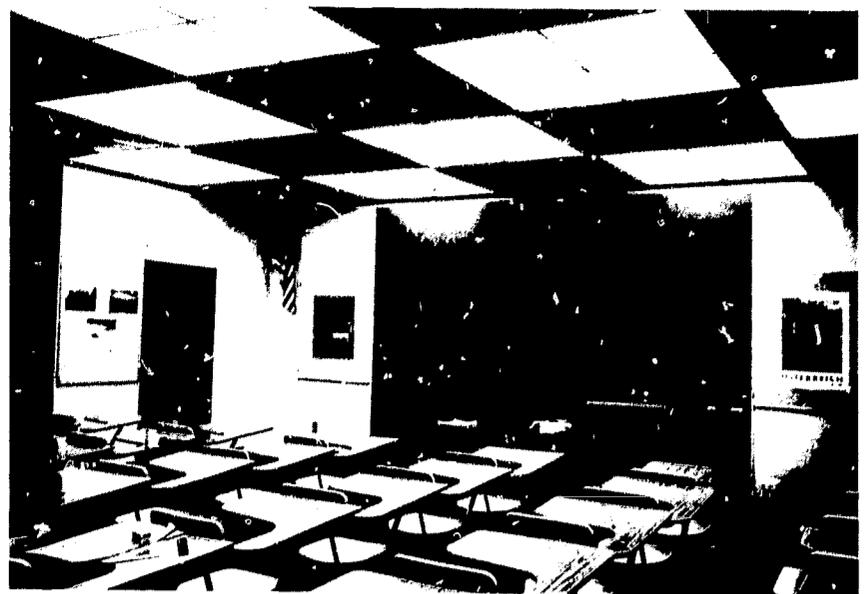
lighting levels

Location	Footcandles Electric	Location	Footcandles Electric
1	83	10	102
2	95	11	96
3	84	12	108
4	102	13	111
5	119	14	60
6	111	15	57
7	96	16	60
8	105	17	63
9	96

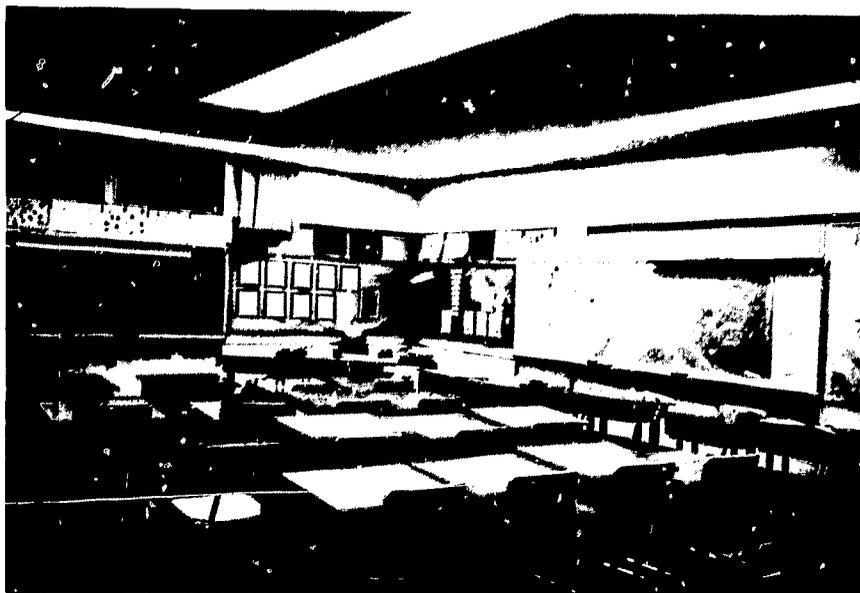
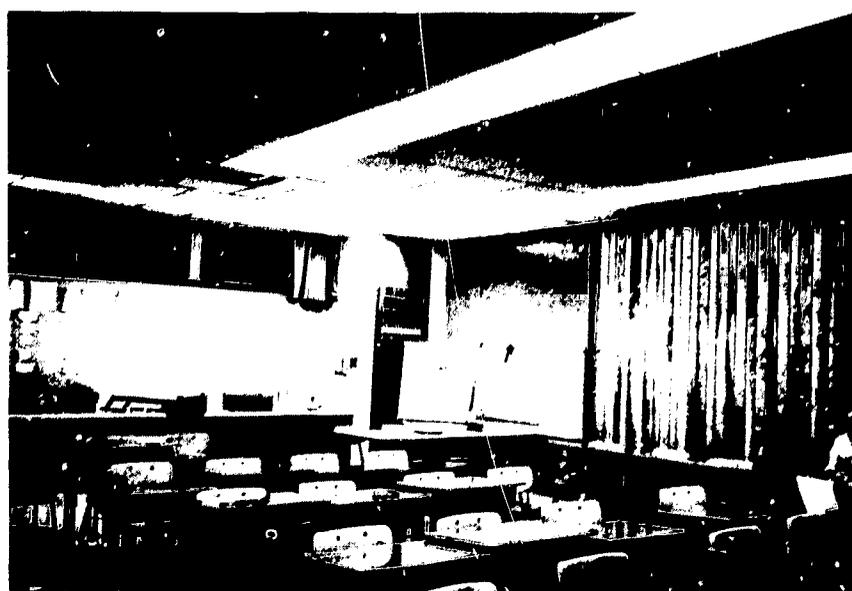
lighting levels

Location	Footcandles Electric	Location	Footcandles Electric
1	114	10	119
2	119	11	126
3	125	12	128
4	120	13	126
5	123	14	69
6	123	15	78
7	120	16	78
8	125	17	84
9	123	18	84

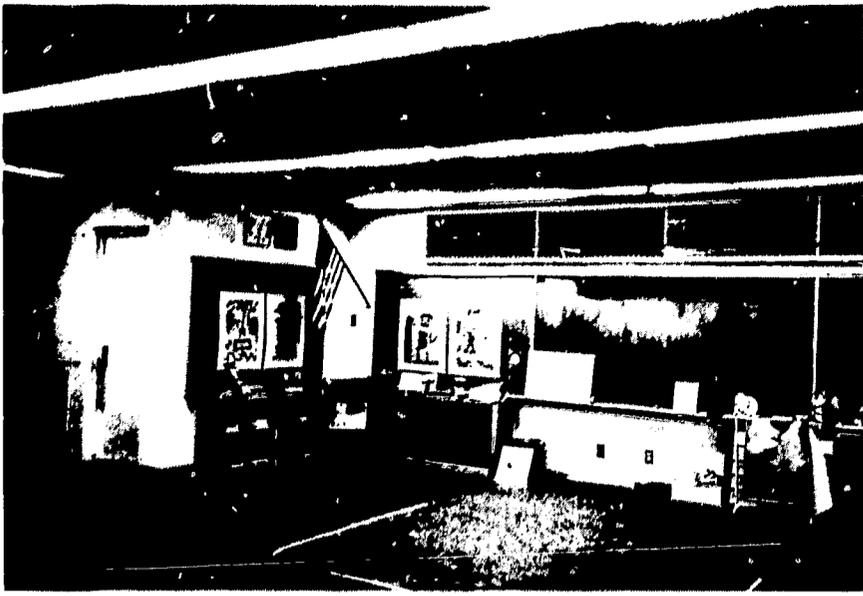
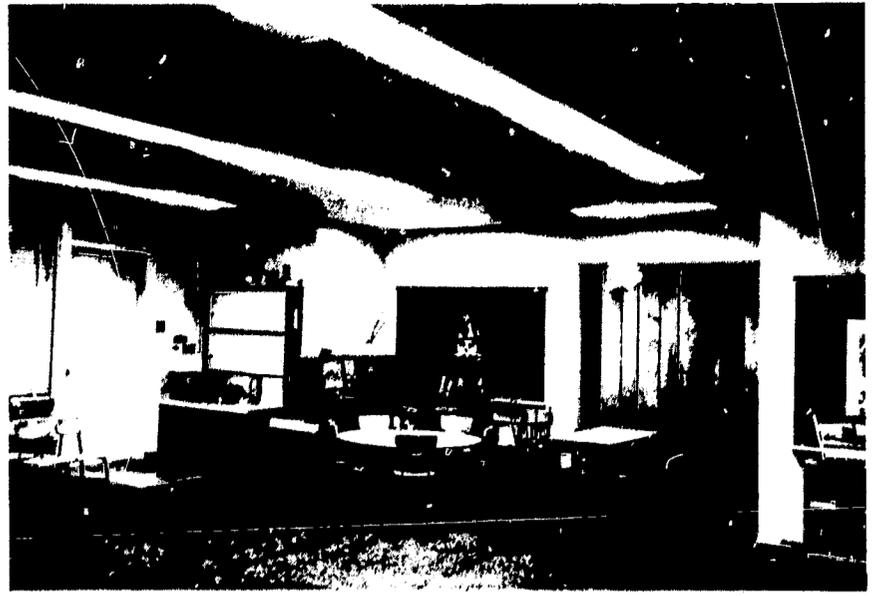
lighting levels

Location	Footcandles Electric	Location	Footcandles Electric
1	72	9	66
2	81	10	96
3	72	11	99
4	111	12	93
5	108	13	93
6	106	14	42
7	69	15	39
8	72	16	63

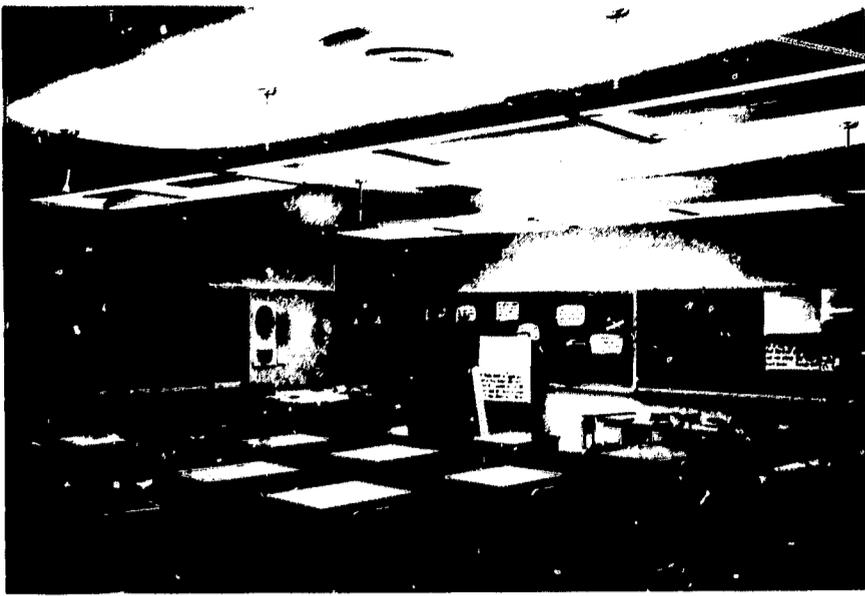
lighting levels

Location	Footcandles Electric	Location	Footcandles Electric
1	78	9	80
2	87	10	96
3	94	11	99
4	102	12	96
5	111	13	96
6	105	14	57
7	75	15	54
8	90	16	72
